**CONDITION REPORT
AND
CAPITAL EXPENDITURE MAINTENANCE PLAN**

**HUGHENDEN COURT
MOUNT PLEASANT ROAD
HASTINGS
TN34 3ST**

**Prepared for
Hughenden Court (Hastings) RTM Company Ltd**

JANUARY 2024

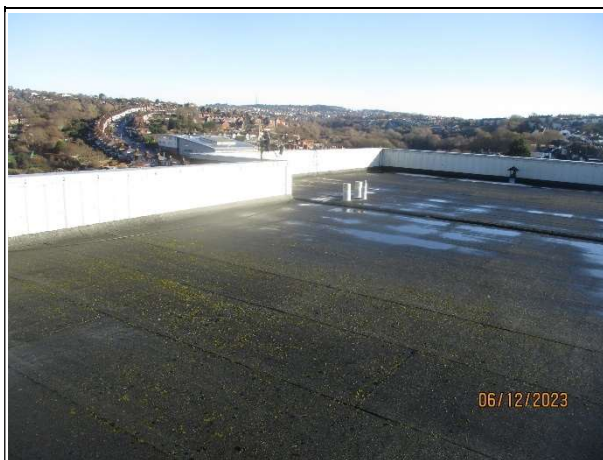
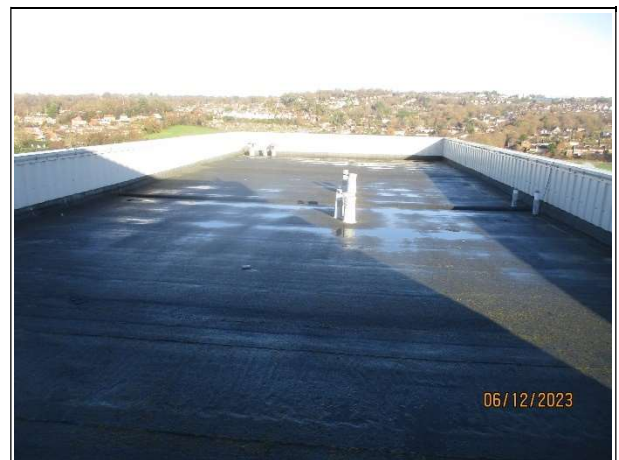
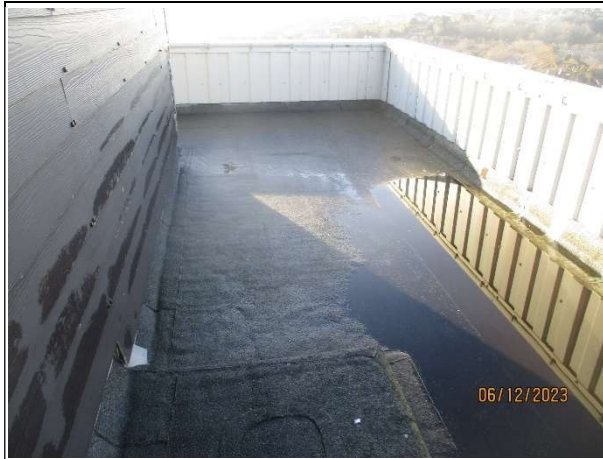
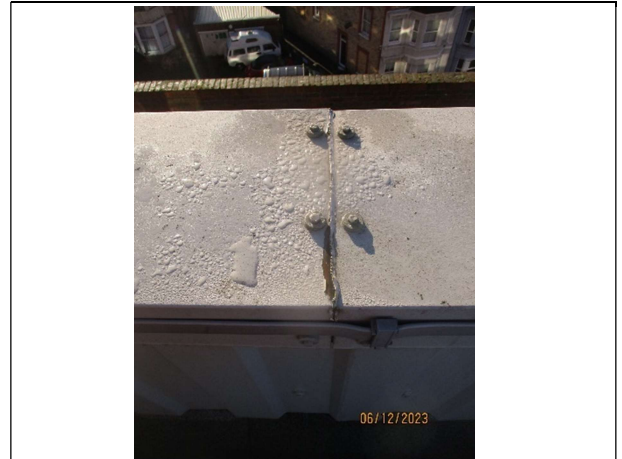
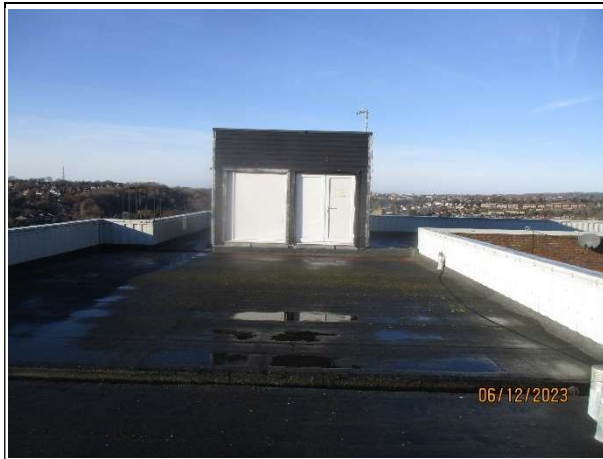
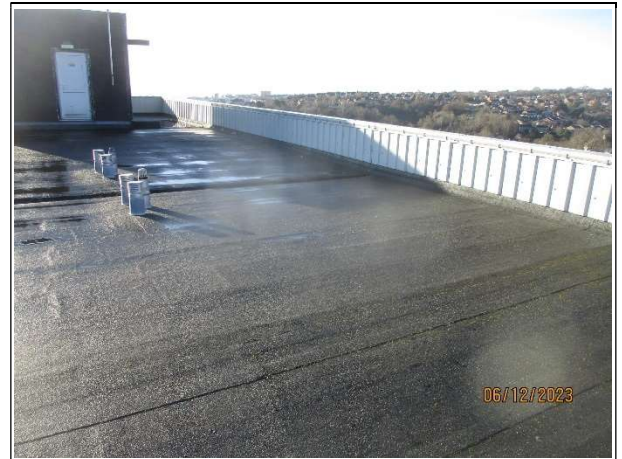
4.1.1 Flat Roof

The main flat roof covering to the building is a modified bitumen felt laid over what is assumed to be a timber roof deck, and is estimated to be well in excess of 20 years old. At the perimeter of the flat roof area is a parapet wall with metal cladding and coping detail. The felt roof covering has been dressed up and under this cladding.

There was evidence of ponding in several locations on the main roof, and a number of localised patch repairs including sections of felt overlay have been carried out. In some areas the flat roof felt spongy underfoot. The roof is considered to be reaching the end of its serviceable life and allowance will need to be made to overlay the existing roof with a new bitumen felt system. It is recommended that some core samples be taken of the main flat roof in order to confirm the condition of the underlying substrate, and to establish if there is any existing insulation within the roof deck.

There are several flues penetrating the roof. These were generally considered to be in acceptable condition, and appear to be in current use. Any flues that can be confirmed as redundant should be removed as and when the roof covering is next replaced, thereby reducing the number of penetrations through the felt roof covering.

The metal cladding to the parapet was generally considered to be in fair condition, but some localised repair or replacement is likely to be necessary when the main roof is recovered. In particular, some of the fixings were noted to be corroded and will require replacement to prevent any future failure or water ingress.

It should be noted that any proposal to upgrade the roof will require upgrades to the thermal performance. It has been assumed that there will be little to no insulation within the existing roof, and therefore allowance will be made within any costs for upgrades to the roof to include for additional insulation.

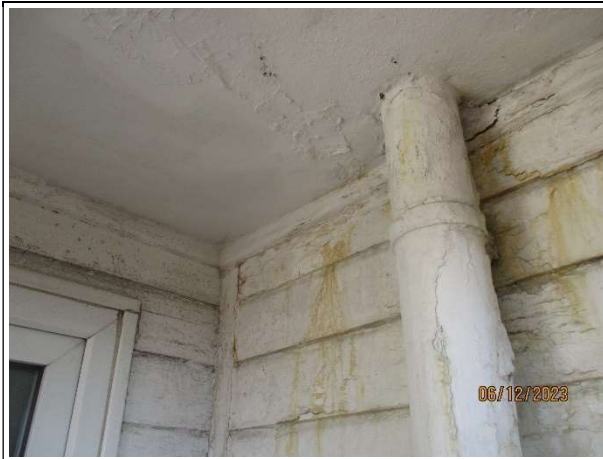
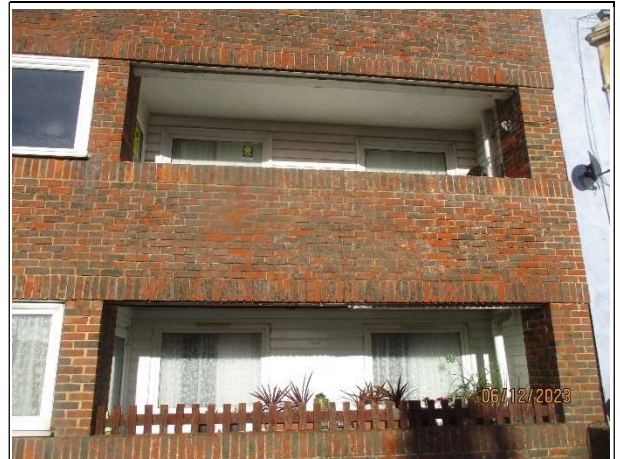
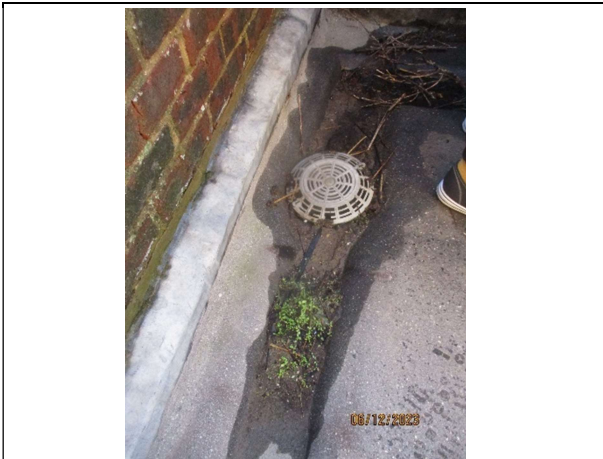
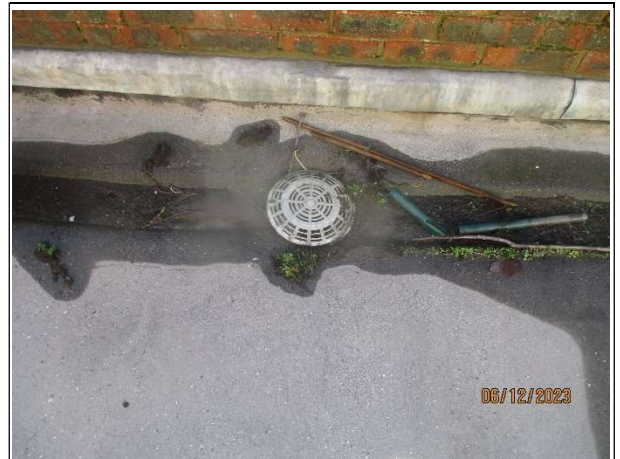
4.2 Rainwater Goods

The rainwater goods to the main flat roof consist of two central valleys which discharge into several gullies, that connect to internal rainwater downpipes. We were advised that there are potentially ongoing water leaks that could be linked to the internal downpipes. No inspection of the internal rainwater pipes was possible due to them being boxed in within the flats below. There are also some downpipes which extend down to the lower ground floor level within the inset balcony spaces below the roof terraces. Only a single balcony was inspected and it is recommended that investigations be carried out to all downpipes, gullies etc to confirm if there are any significant issues or defects. An allowance has been included for some general maintenance and repairs in the attached cost plan.

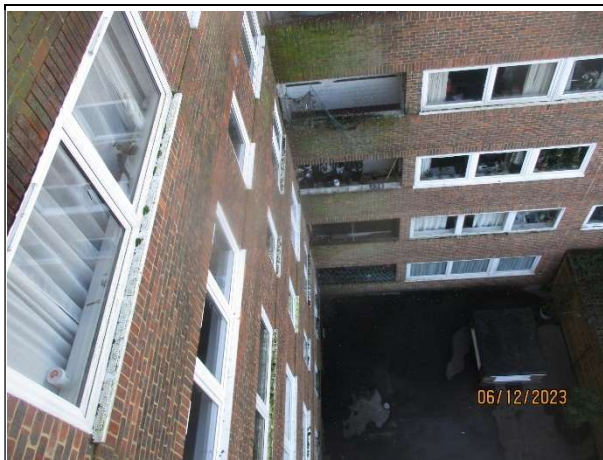
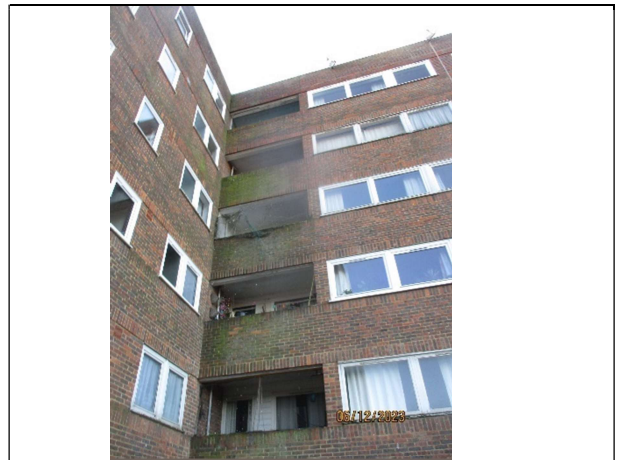
4.3 Roof Terraces and Balconies

To the fourth and fifth floor, there are a number of flats which have external terrace areas which are formed of a concrete deck with a covering of asphalt. We were provided with a copy of a report carried out by Danosa following an inspection in June 2023, in which a core sample was taken. The report concludes that the asphalt surfacing is approximately 40+ years old and is at the end of its serviceable life and is need of renewal. Our inspection confirmed that there is evidence of splits to a number of areas of the asphalt and we saw localised patch repairs have been carried out to a number of locations.

In addition, we have been advised of a number of internal leaks to the flats below the terrace areas. These leaks could be as a result of the asphalt condition but also are likely to be linked to poor detailing at the upstand around the perimeter of the terraces. Some repairs have been carried out including replacement lead flashing and cavity tray installation, but there is evidence internally of ongoing issues with water ingress.

The majority of flats are all served with inset balconies to the front and rear of the block. The balconies are of concrete construction formed as part of each floor, and are enclosed with masonry walls which have received a painted cladding finish. The balustrades are brick construction with a brick coping detail.

There was evidence of some corrosion to the reinforcement within the concrete balcony structure that was inspected as part of this survey. From ground level via binoculars there is further evidence of defects to a number of balconies around the block. There is also evidence of water ingress and associated damage to a several balconies. Allowance for some repairs will be included in the attached cost plan, but initially it will be necessary to carry out further inspections to individual balconies including concrete hammer tests etc to determine the extent of remedial works required.

As with the main roof, any proposal to upgrade the terrace roof deck will require upgrade to the thermal performance of the roof and will require additional insulation to be installed. This will also require

alterations to the upstand details to be carried out, and the opportunity should be taken to carry out further investigations into the cavity trays and flashing installation to ensure that any remedial works to prevent further water ingress from occurring.

It is also likely that due to the increase in the depth of the roof covering that the parapet walls will require adaptation to ensure that they provide adequate protection from falling for the occupants of those flats with access to the terrace areas.

The cladding to the enclosed balconies will require redecoration as part of any future remedial works to the external elevations.

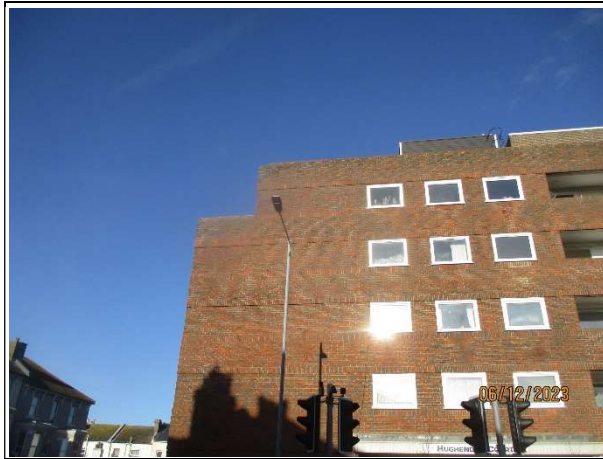
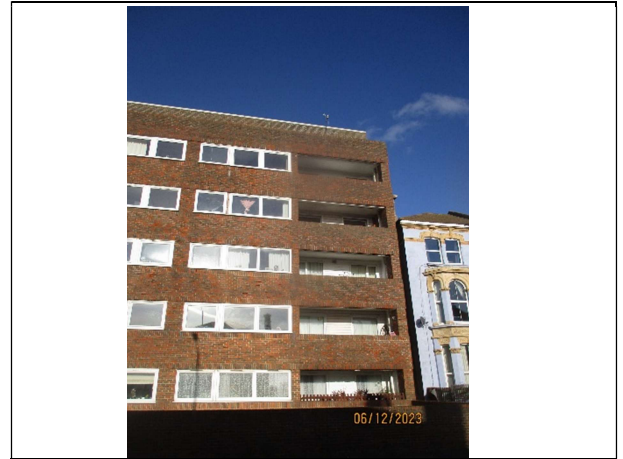
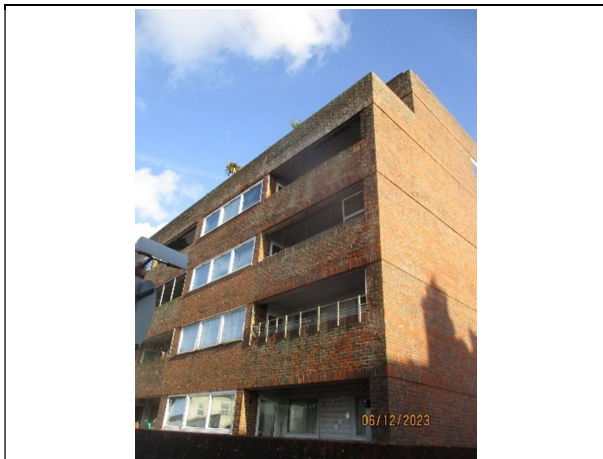
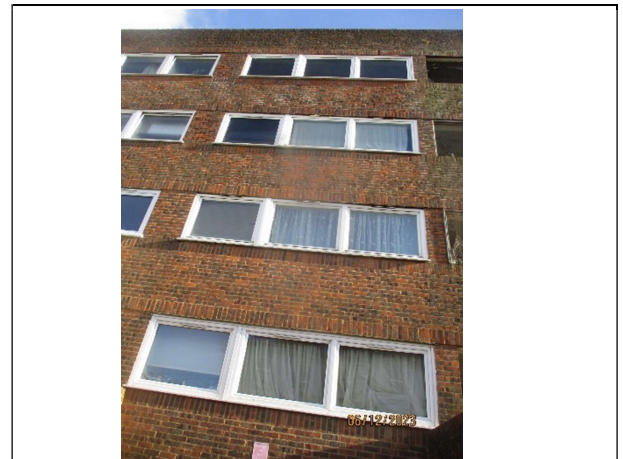
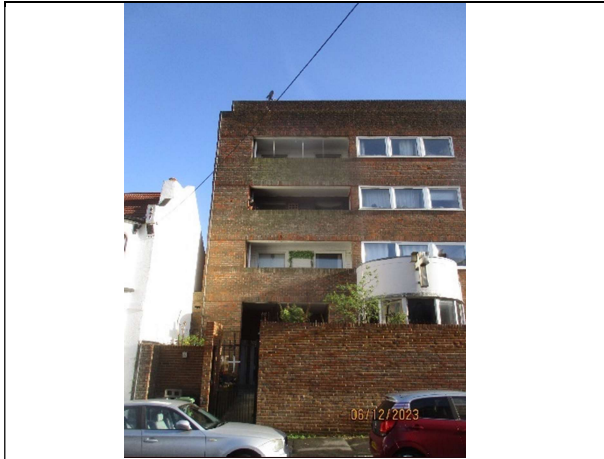
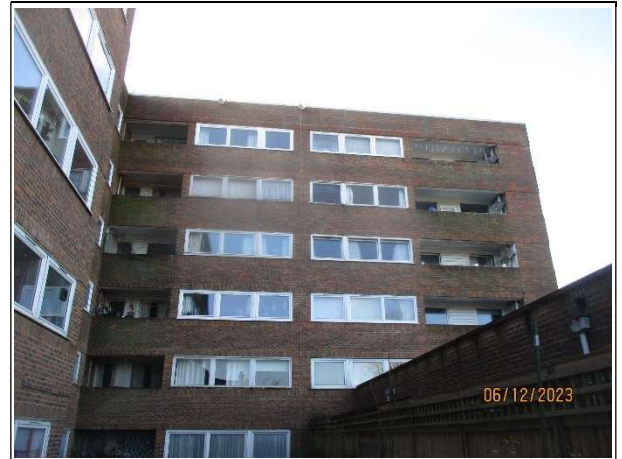
4.4 Elevations

The external elevations are formed of cavity construction with facing brickwork. Generally, the pointing to the brickwork is considered to be in poor condition with some significant areas where the pointing has eroded completely along with patches of brickwork that has suffered from substantial spalling.

Further to the visible defects to the brickwork there are reported ongoing issues related to water ingress throughout the block. This is considered to be as a result of a combination of defects including the condition of the pointing and brickwork, but also linked to issues regarding the cavity trays over window openings. Repairs will be required, but it is recommended that once scaffolding is in place that further investigations be carried out to the cavity brickwork in order to establish the cause of the water ingress and to allow suitable remedial works to be carried out.

As part of the recommended remedial works described above, it is also thought that due to the age of the building, that there are potentially issues with the cavity wall ties. An allowance will be included in the attached cost plan for replacement wall ties to all elevations. However, the full extent of this element of work will only be confirmed once close up investigations can be carried out from a scaffold. It is possible that the amount allowed within the cost plan may not need to be fully expended if it is found that some (or all) of the cavity wall ties are in an acceptable condition.

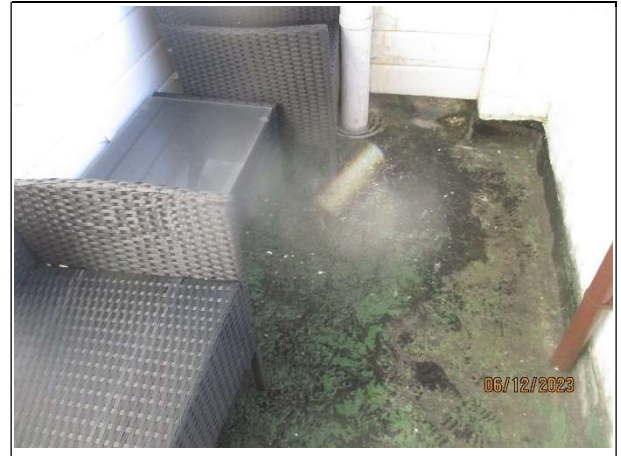
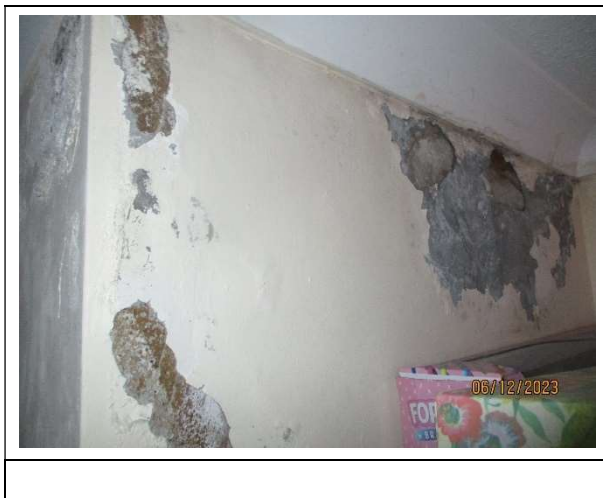
4.7 External Plumbing

There is no significant external plumbing to the building. As described earlier, much of the rainwater is directed to internal downpipes that are concealed within boxings within the flats. In addition, all foul water drainage pipework is concealed within boxings within the flats and therefore the above ground drainage pipework cannot be commented on.

Some of the downpipes penetrate through the recessed balconies, and extend down to the undercroft parking area. We were only provided with limited access to a single balcony, but have been advised that there are ongoing issues with regard to water leaks that are likely linked to the boxed in rainwater downpipes.

Further investigation may be required to determine the location of any leaks, and a provisional allowance has been included in the cost plan for repair to be carried out.

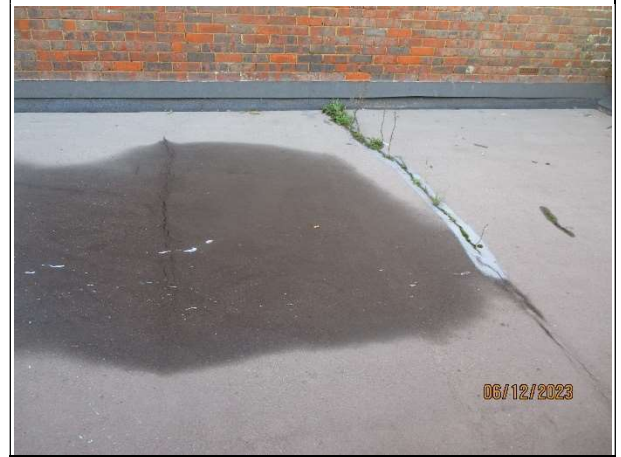
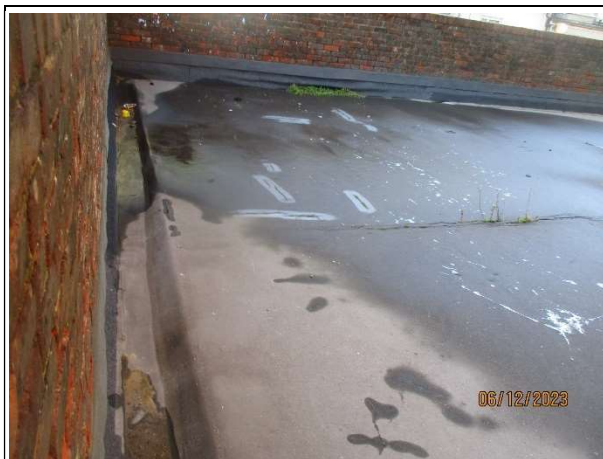
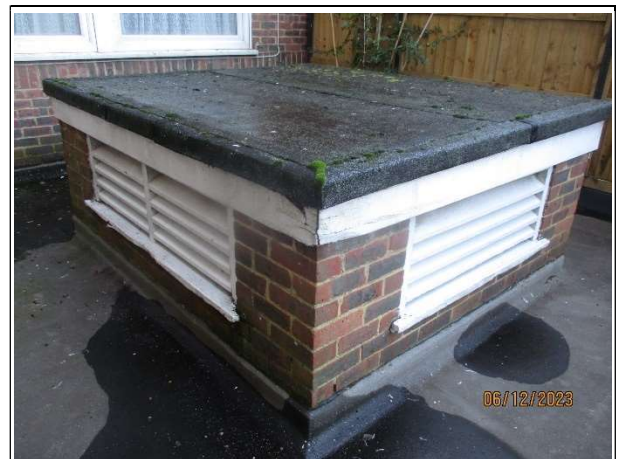
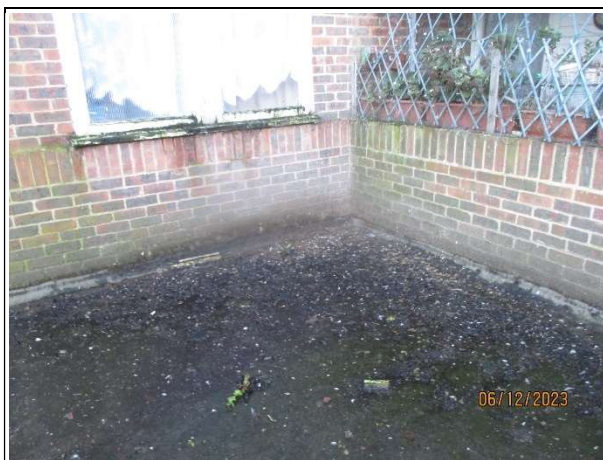
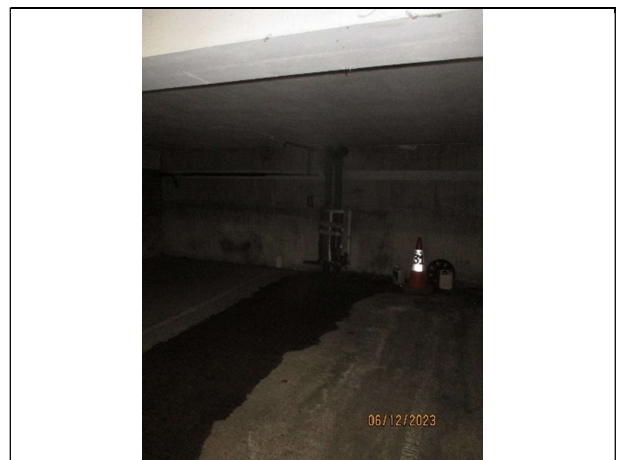
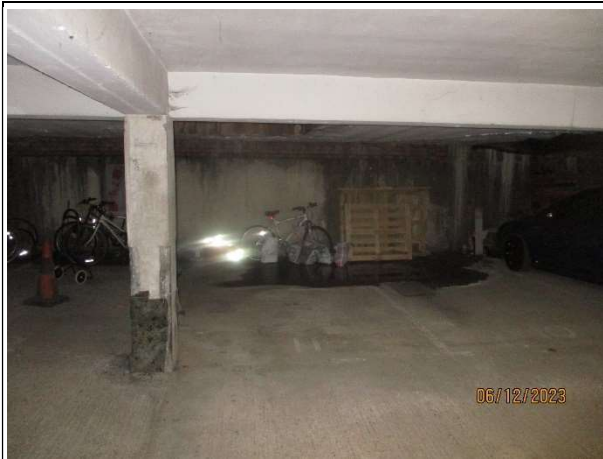
4.8.1 External Areas and Car Park

To the front and rear of the building there are terrace areas which are covered in asphalt with several brick built vents that serve the undecroft parking area at lower ground level. The asphalt surface is cracked in several areas and there is evidence of ponding in a number of locations. There is also evidence of water ingress to the car park area below. As a minimum localised remedial works will be required in the short term, but it is anticipated that longer term more significant repairs including replacement or recovering of the asphalt surface will be necessary. It is recommended that some core samples are taken of the asphalt in order to determine what condition it is in, and what the anticipated remaining lifespan is.

Water damage to the concrete ceiling within the car park area is an ongoing issue, and remedial works will be necessary. Further investigation is recommended to establish the extent and severity of any defects. A provisional sum has been included in the cost plan until a more definitive scope of works can be confirmed.

At the front entrance to the block, there are steps with a covering of concrete paving slabs. Remedial works including removal of weed growth, and replacement of the asphalt upstand will be required. There is also some damage to the metal handrail where it is fixed into the paving slabs that will need attention.

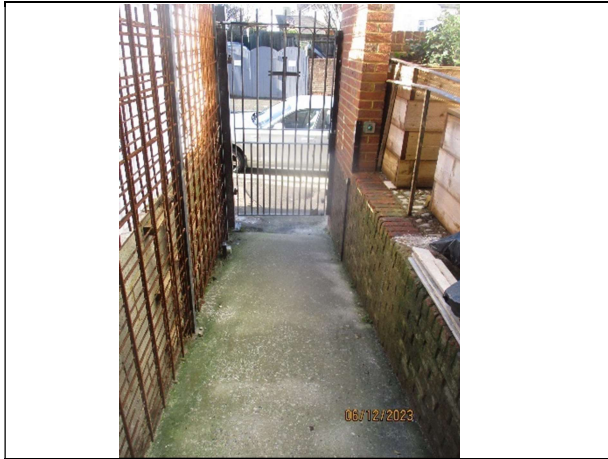
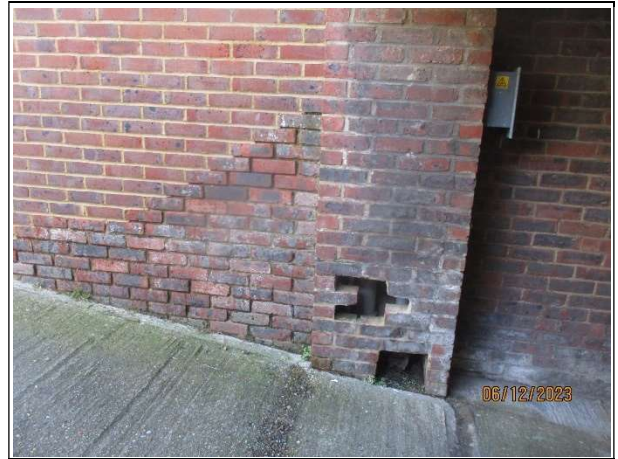
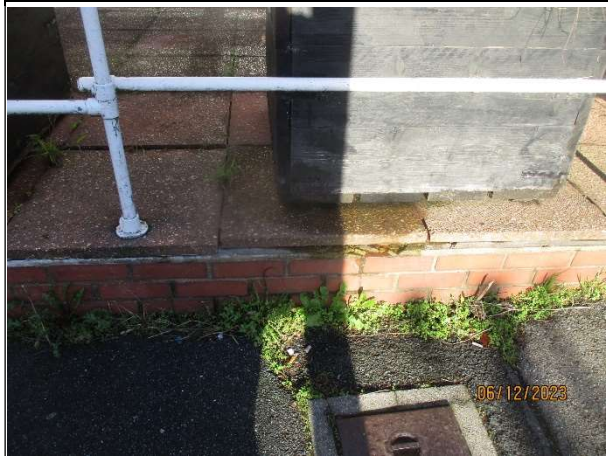
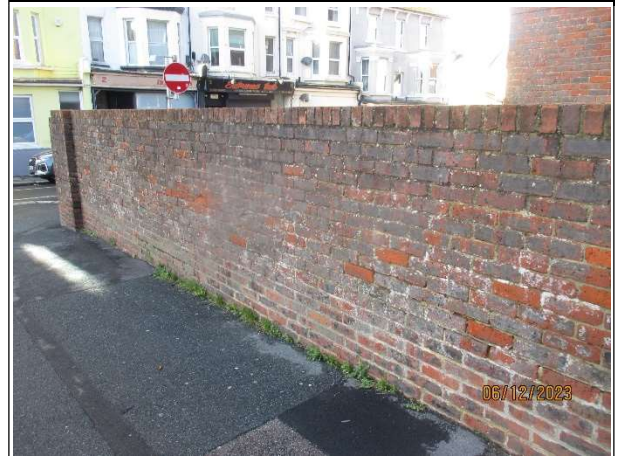
4.8.2 Boundary Features

The front boundary is demarked by a brick wall which encloses the asphalt covered terrace area. This brick wall extends around the corner onto the west facing elevation. The brick wall becomes a retaining structure at the access road into the undercroft parking area. In general the boundary wall is in fair condition, but some localised repairs to frost damaged brickwork will be necessary.

There is an area of brickwork on the ramp to the car park area where a number of bricks have been removed and not replaced. These bricks should be replaced at an early opportunity.

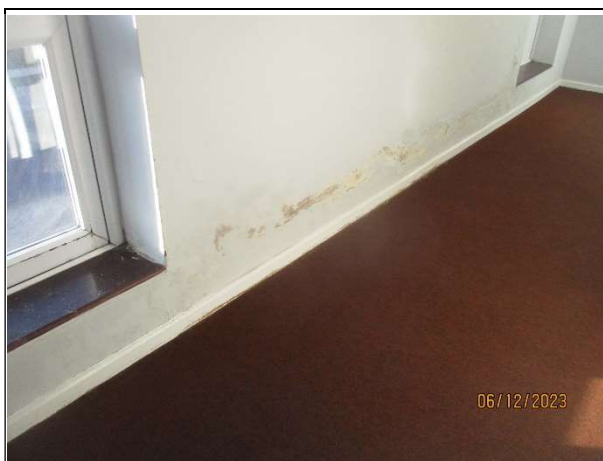
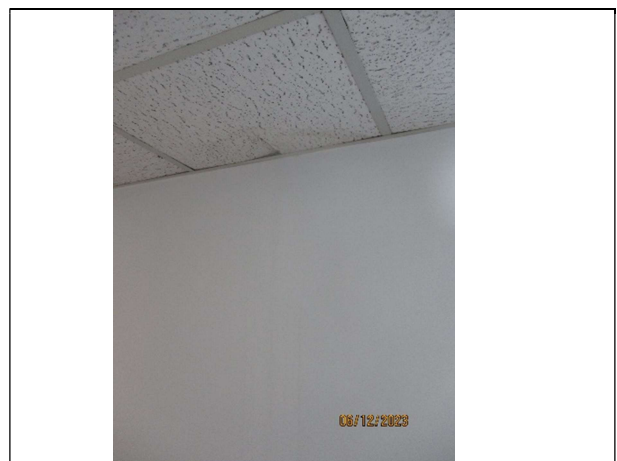
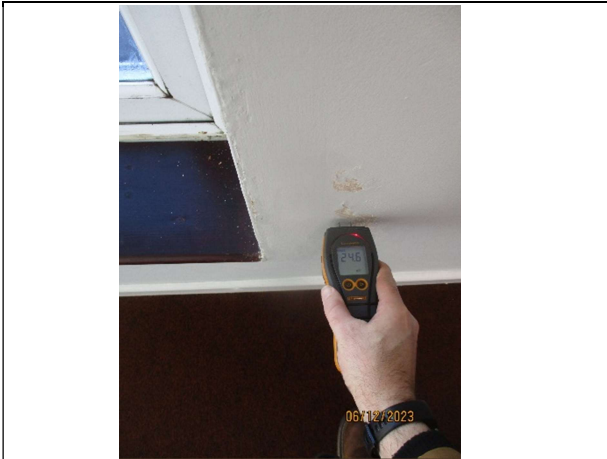
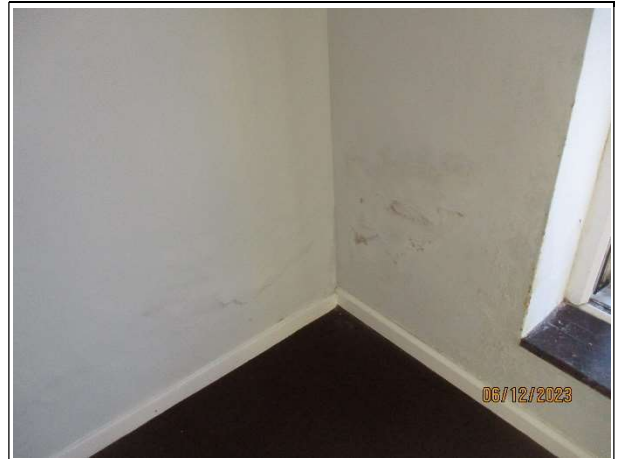
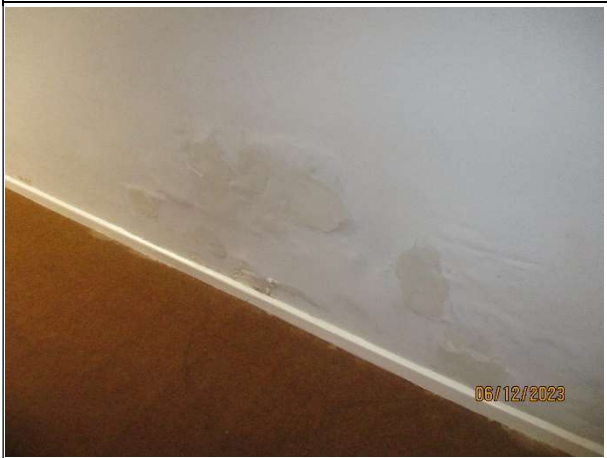
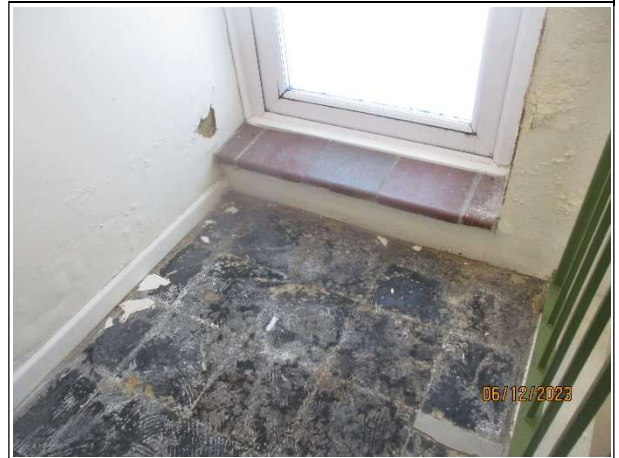
4.9 Internal Communal areas

The internal communal areas are formed of plastered walls, with painted softwood timber skirting boards and architraves etc. All of the communal areas have suspended ceiling which are covering a hollow pot floor construction. The concrete stairs have metal painted balustrades of steel with a plastic covering to the handrail. The majority of communal corridors have received a carpet finish, whereas the landing areas and stairwell floors have received a tile finish. These have the appearance of tiles that would typically contain asbestos and this has been confirmed in the asbestos report. The majority of the communal areas have no significant defects. Some of the asbestos tiling to the stairwells and landing are damaged, and removal and replacement of these tiles is recommended, but as the tiles contain asbestos, this should only be carried out by a licensed contractor. To some of the landings, all of the floor tiles have been removed, but due to ongoing water ingress, no attempt to replace the tiles has been carried out. Floor coverings such as carpets will require replacement approximately every 10 years. Some of the carpets will require replacement in the short term where damage has been caused due to other factors such as water ingress caused as a result of external defects. Any external defects should be rectified before any carpets or floor tiles are replaced. The communal areas should be re-surveyed in 5 years' time to assess their condition.

Painted decorations throughout the staircase and communal areas appear to be generally in fair condition, but with some areas having been damaged due to external water ingress. Due to significant and ongoing water ingress, some sections of walls to communal corridors will require remedial works before any redecoration should be carried out. As with the carpets, any external defects should be rectified prior to carrying out any internal making good and redecoration. An allowance for redecoration of the communal areas has been included in year 5 of the maintenance plan.

The ceilings to the communal areas are generally suspended ceiling tiles. For the most part the ceiling tiles are in fair condition, but some water damage has been caused in a number of locations. Similar to the carpets and walls detailed above, any ongoing defects should be rectified prior to any repair works.
