Survey Report

Hughenden Court, Mount Pleasant Road,
Hastings

Project Name	Hughenden Court, Mount Pleasant Road, Hastings
Area Name / Reference (if applicable)	No 35 terrace
Client	Homeowner/Director
Report Conducted By	Bob Saul
Site Visit / Report Date	2023-01-06

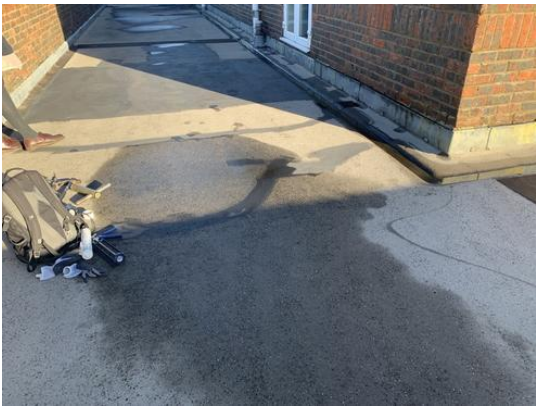
Photo 7

Ponding Water

Yes

Only in the gutter, there is only 1 outlet in the gutter for this area and hasn't been maintained. The ponding water may drain freely of the leaf guard to the outlet was cleared regularly.

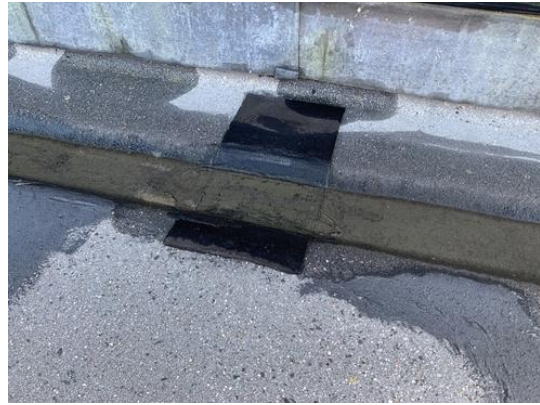
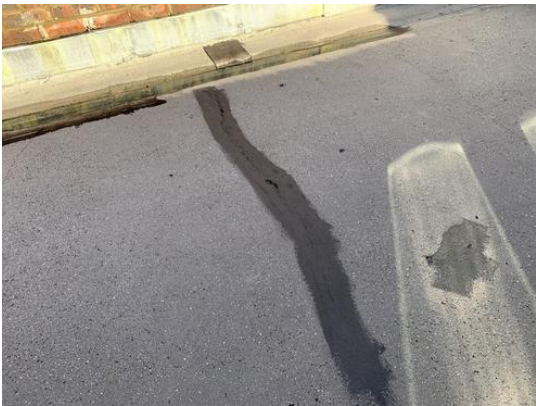
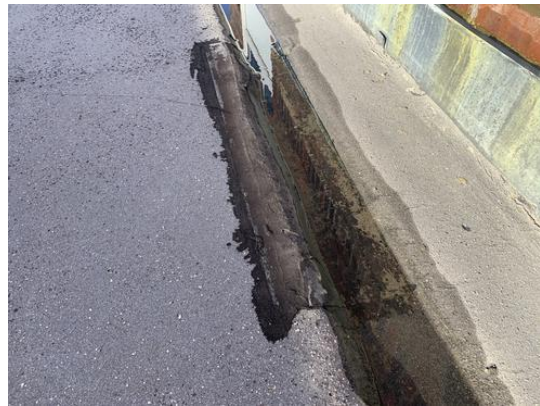
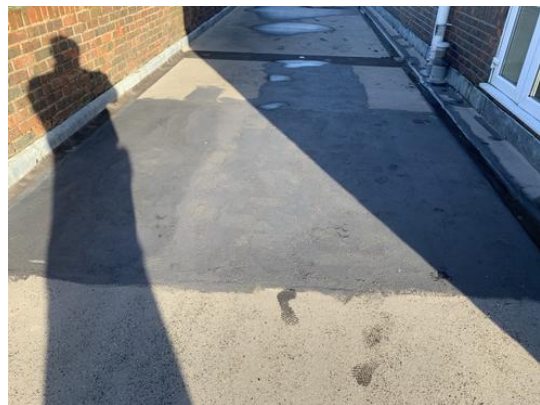
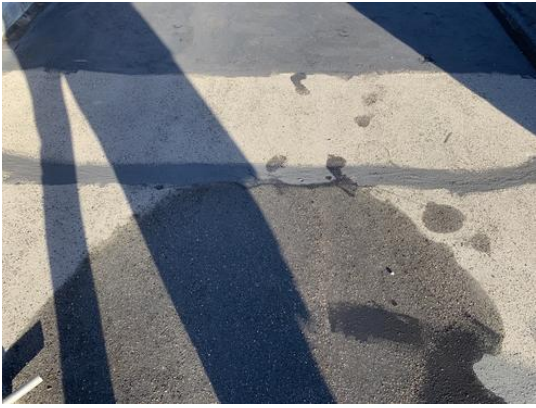
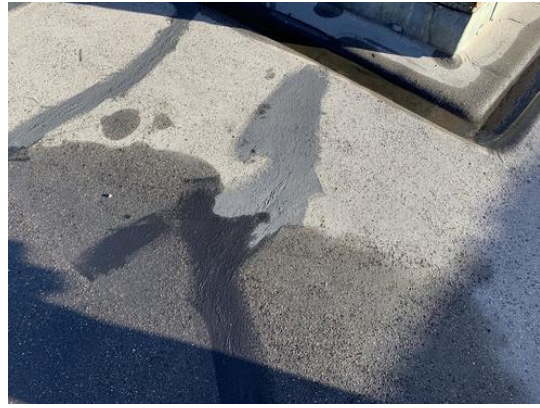
There have been various repairs carried out to the existing roof with liquid repairs covering cracks and some felt repairs carried out. We are unsure how much longer these repairs will last.

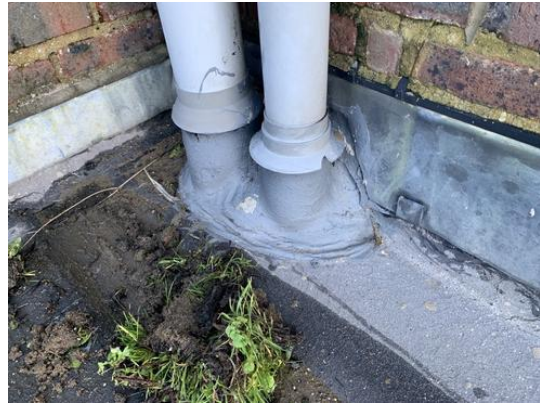
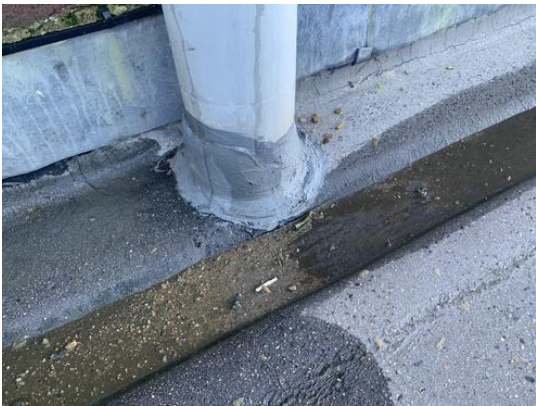
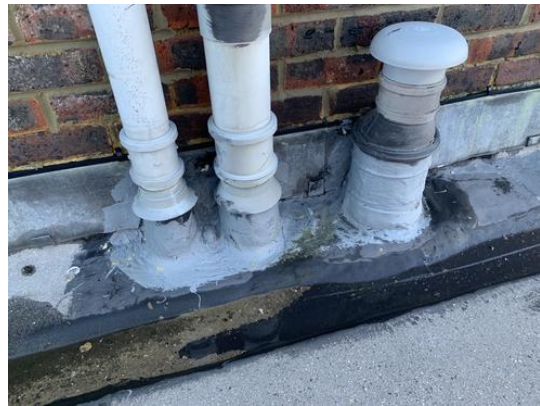
There have been some poor liquid repairs carried out to some pipe penetrations. From photos shown to me on site by the director these are still leaking and allowing water into the persons flat below.

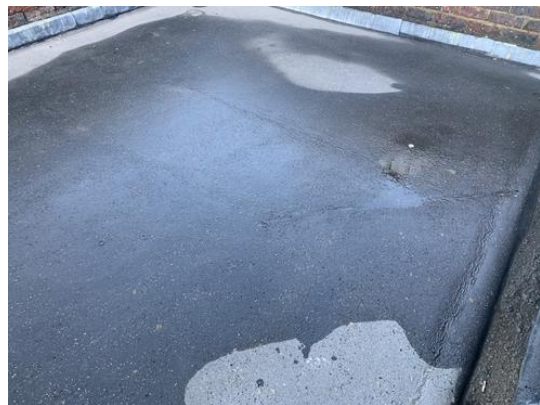
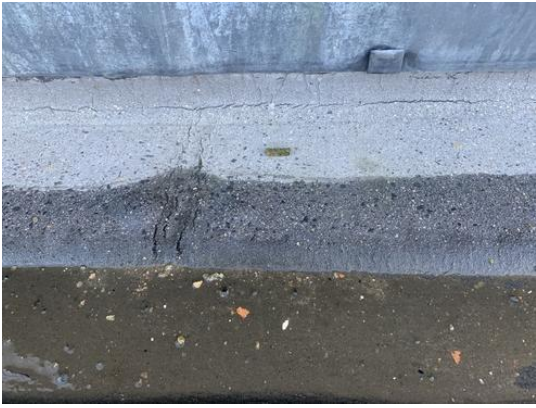
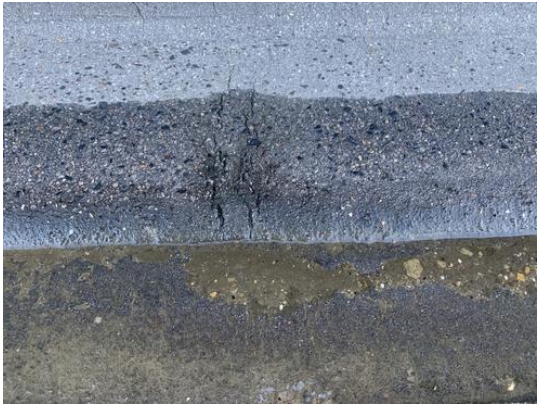
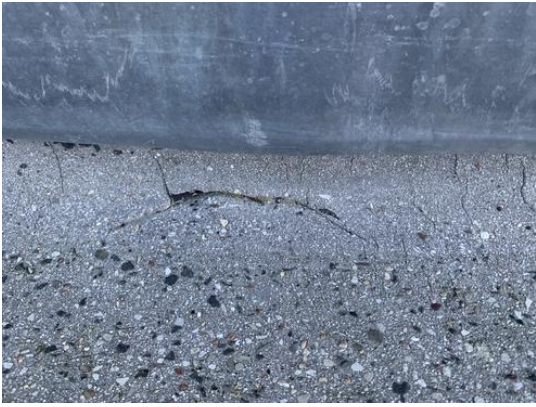
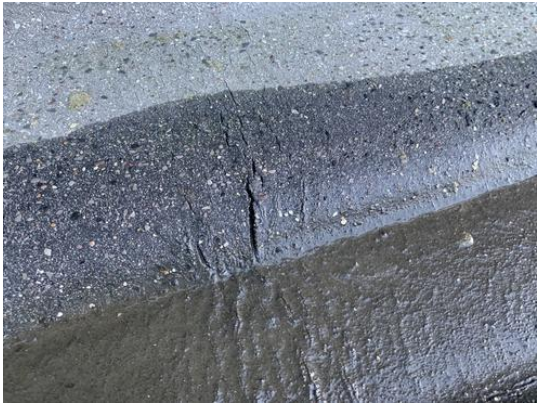
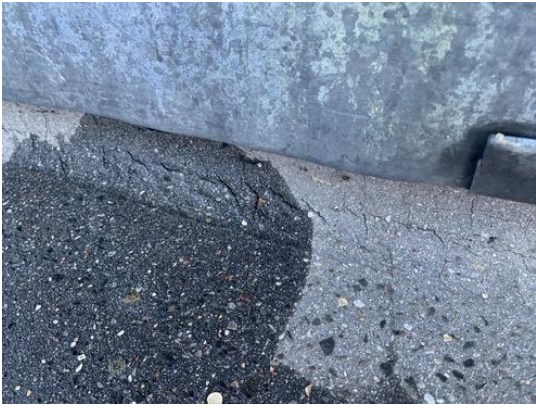
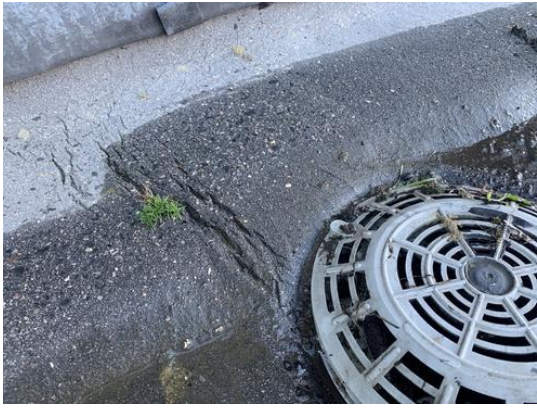
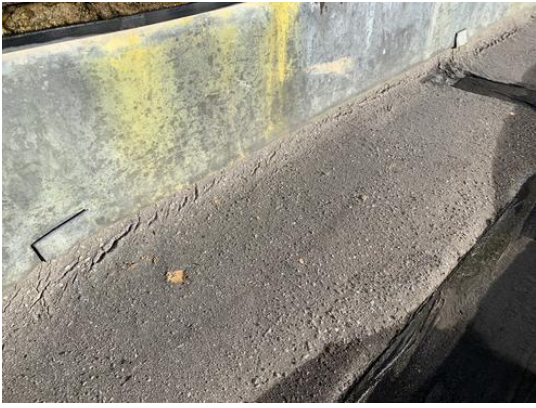
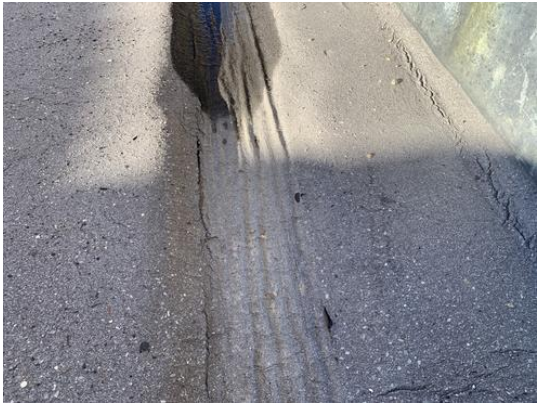
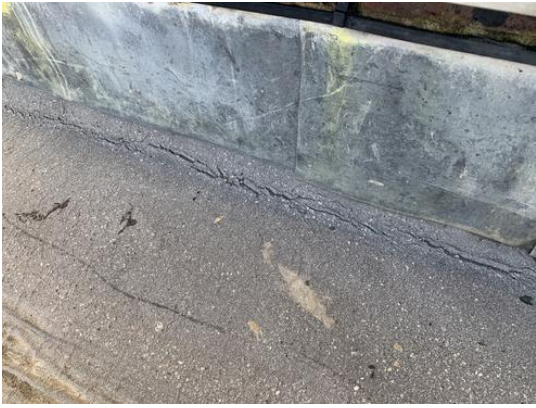
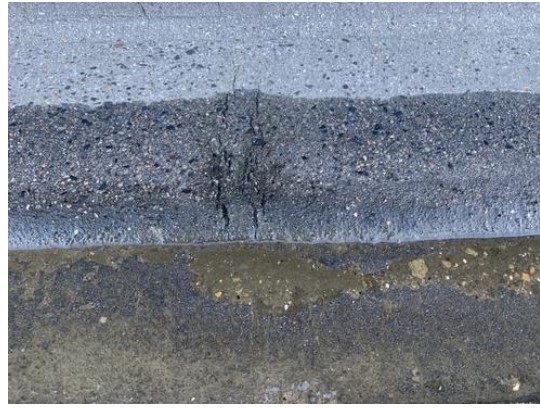
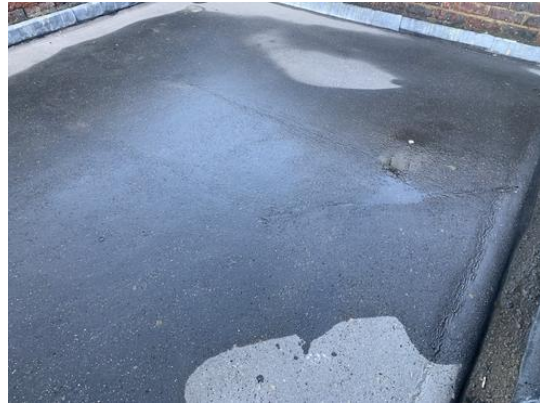
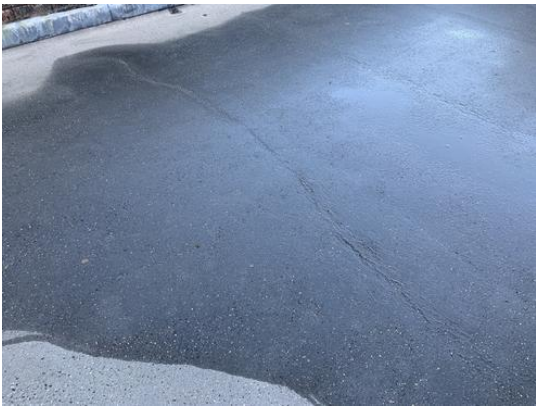
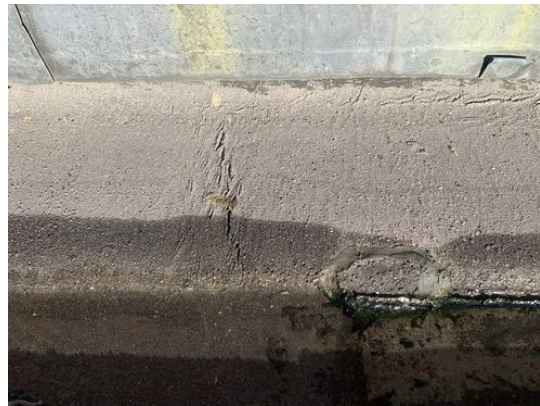
There are various cracks in the existing asphalt roof covering which will allow water into the building.

Any areas where the existing waterproofing is damaged, cracked can be repaired then it should be repaired, primed with BITUMEN PRIMER+ SA and a SELFDAN AP 2000 AVCL installed to any areas this occurs

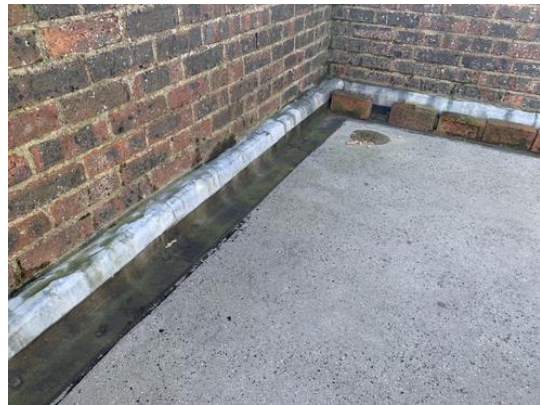
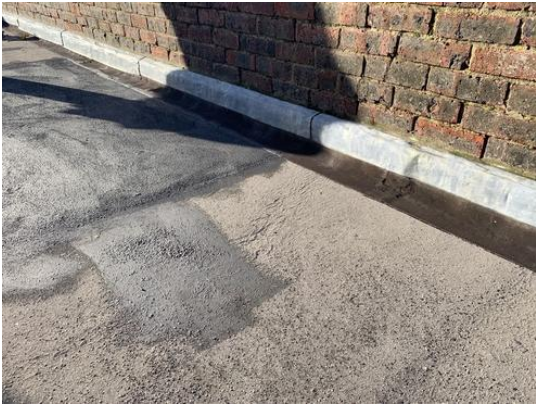
The parapet perimeter upstand detail has had some felt repairs carried out which look to be still adhered but we can't be sure how long these will last. We are assuming these repairs are covering some cracks in the asphalt.

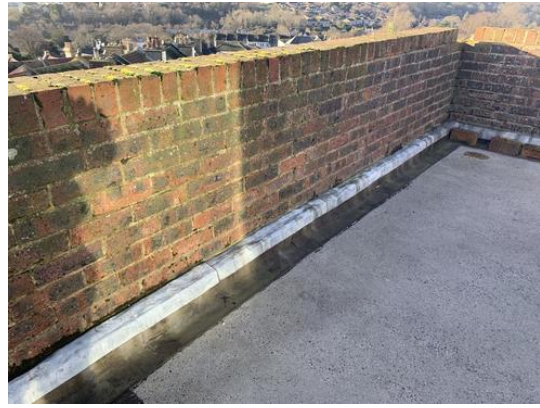
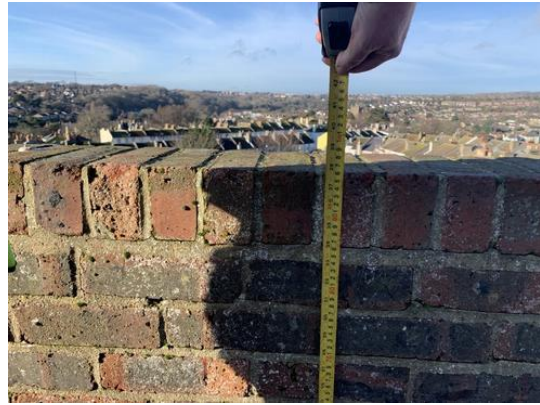
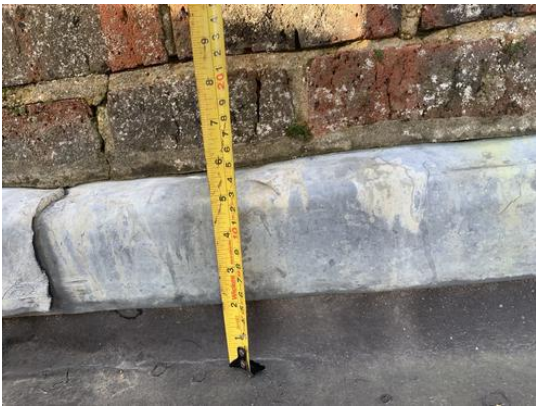
With the new proposal of upgrading the roof and adding insulation, from a health and safety point

of view the parapet wall may require raising as we are proposing the deck will be insulated therefore raising the deck of the terrace area leaving the parapet to low be complaint to health and safety laws. The parapet detail upstand to the lead flashing is currently 150mm this will need to be raised to ensure there is a minimum 150mm waterproofed upstand installed above the new roof finishes so above the paving slab proposal.

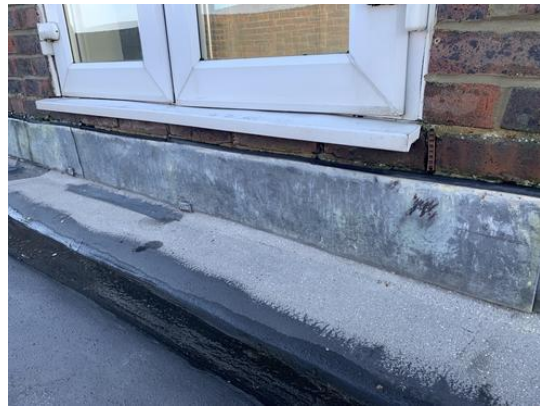
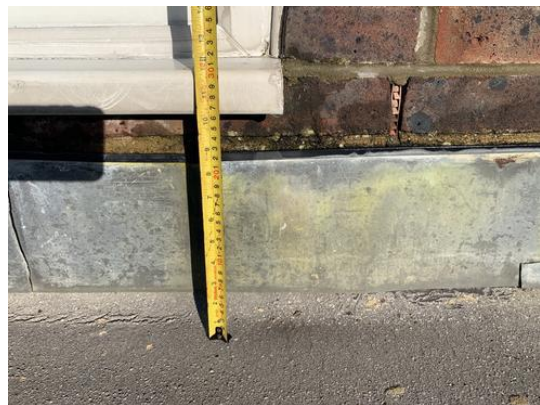
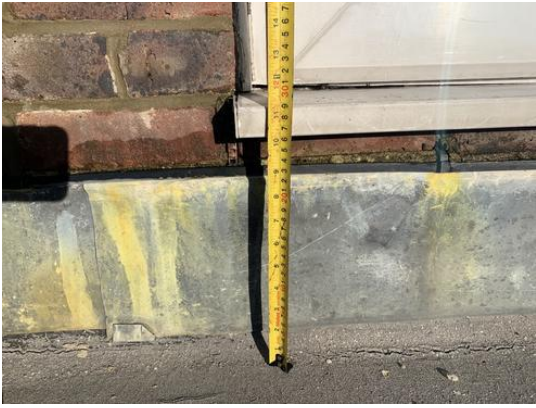
The brick abutment internal upstand detail has limited height due to the cavity tray already installed with the extra insulation height this will only leave a waterproofed upstand of approximately 90mm. This is still not inline with Danosa UK standard detail and British Roofing standards. All details as highlighted in the Roofing British Standard 6229:2018 should allow for a minimum 150mm high waterproofed upstand above the new roof finish. Therefore leaving the detail non-compliant. While the detail would still be non-compliant due to the minimum upstand requirement not being achieved, our recommendation is to install a lead counter flashing dressed in to the brickwork a couple of courses above the top of the waterproofing. The lead counterflashing should dress down to overlap the waterproofing upstand by 150mm, i.e. below the ballast level. The lead flashing should allow sufficient ventilation gap to the weep vents. This would reduce the risk of rainwater ingress due to splash-back of rainwater but would not alleviate the minimal risk of rainwater ingress should there be localised flooding under the ballast line.

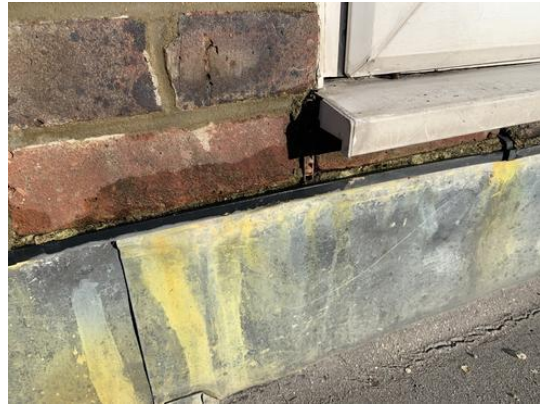
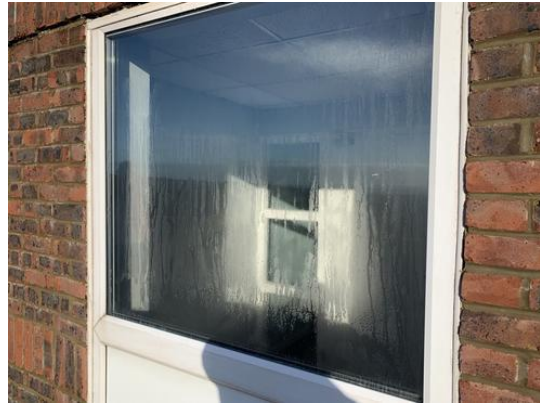
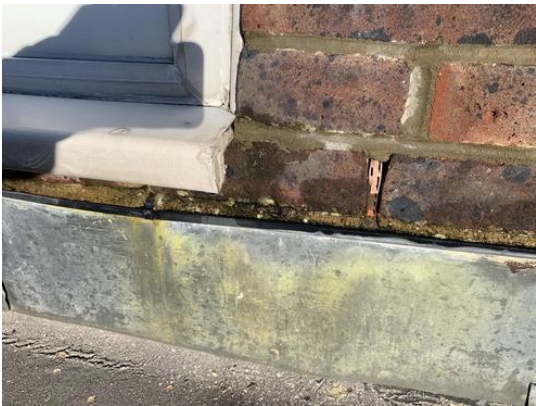
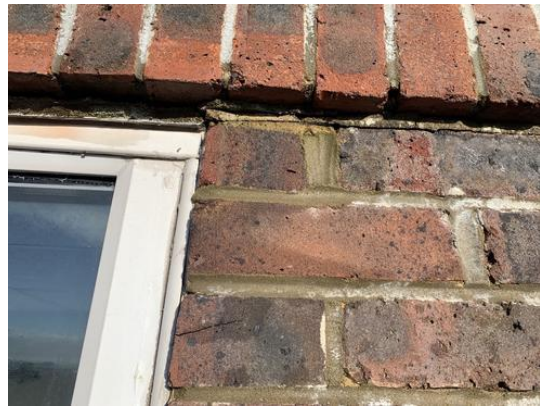
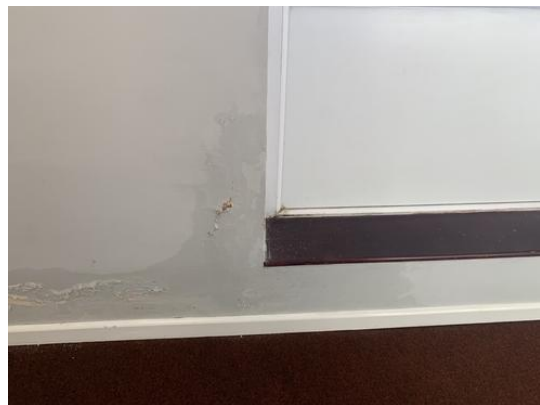
The brickwork looks to be saturated at the base of the cavity and also in higher areas of the brickwork. There is a lot of damp internally plus condensation visible at the window. There seems to be an issue with the cavity of the brickwork wall that we would recommend is addressed.

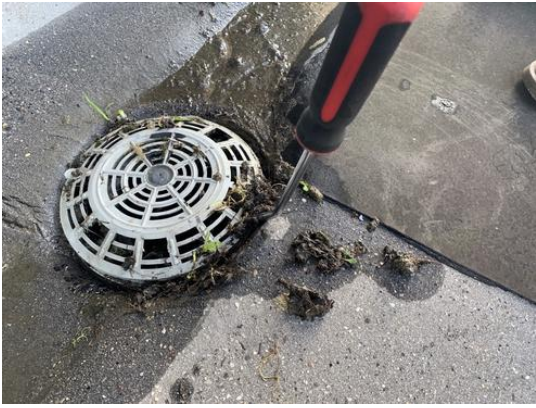
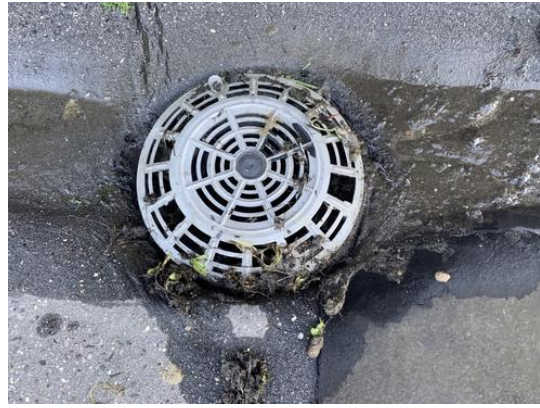
I was informed of water ingress in the area of the outlet. Not fully visible but using my probe I was able to probe underneath the asphalt around the outlet so there is a clear failure of the existing waterproofing in this area. There is only 1 single outlet on the terrace.

Note that where roofs do not drain to external gutter runs, then roofs should allow for a minimum of 2nr outlets, either rainwater outlets or a single rainwater outlet and an overflow spigot matching the water flow rate of the outlet which, when in operation, is visible from ground level, as per British Standard BS EN 12056-3: 2000 'Gravity drainage systems inside buildings – Part 3: Roof drainage, layout and calculation'.

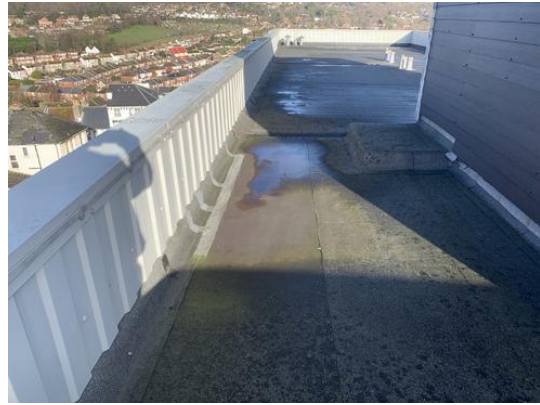
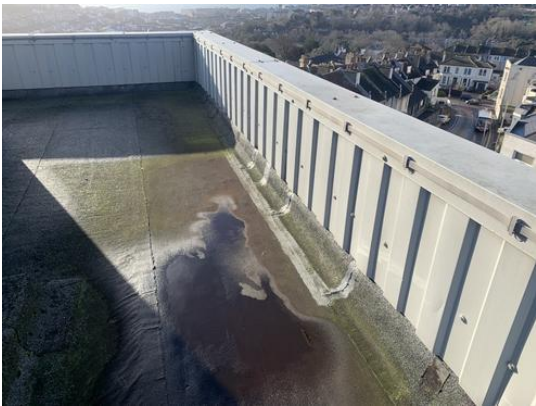
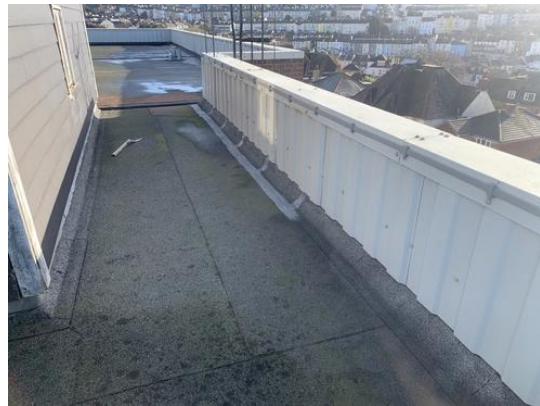
I looked on the roof above this terrace to see if I could pinpoint the issue with the damp brickwork. The existing asphalt roof covering has been overlaid with a bitumen mineral covering and is looking worn and old. The mineral covering is fading leaving the bitumen exposed and no longer UV stable. There were some repairs carried out in a liquid to the joints in this area.

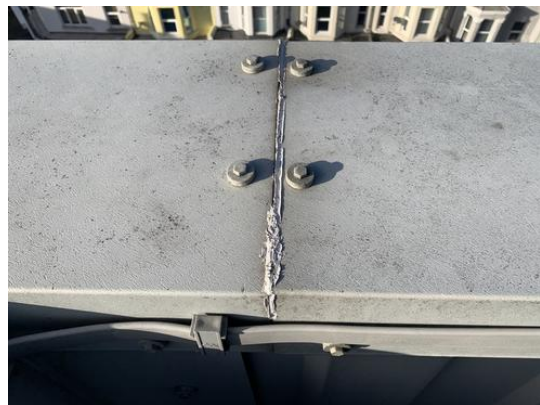
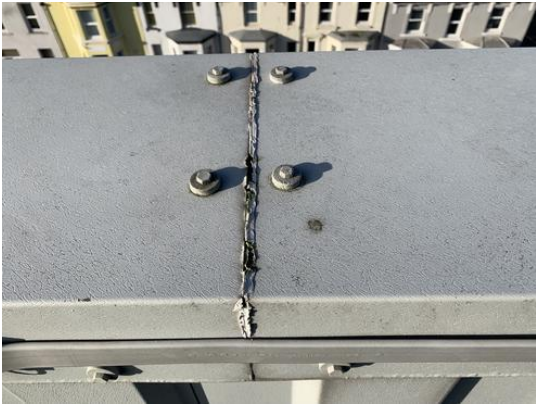
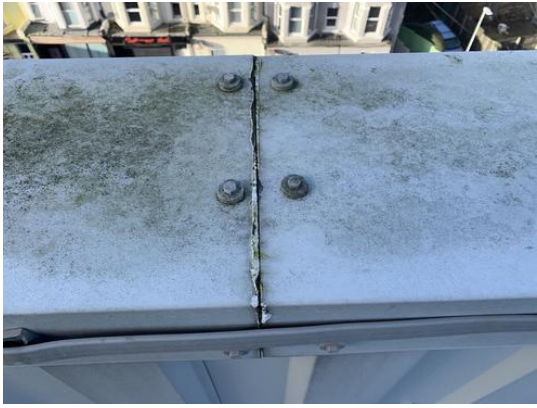
Also a cause for concern on the main roof above the terrace is the capping installed which is for aesthetic reasons only but could be allowing water into the cavity through the joints as the mastic has split.

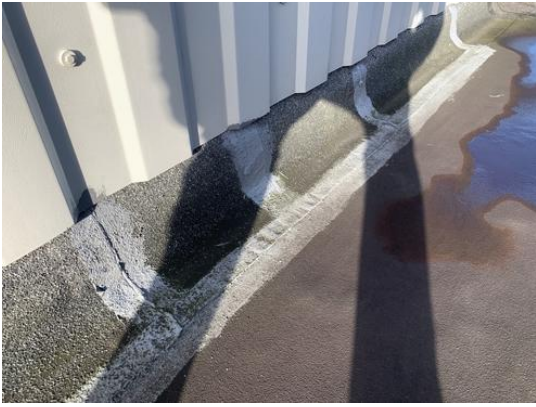
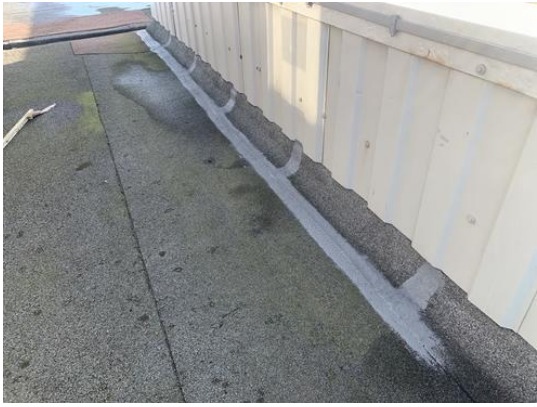
Here are some photos of the repairs carried out to the laps of main roof.

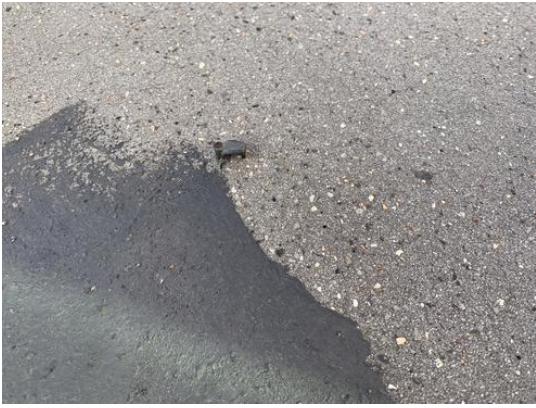
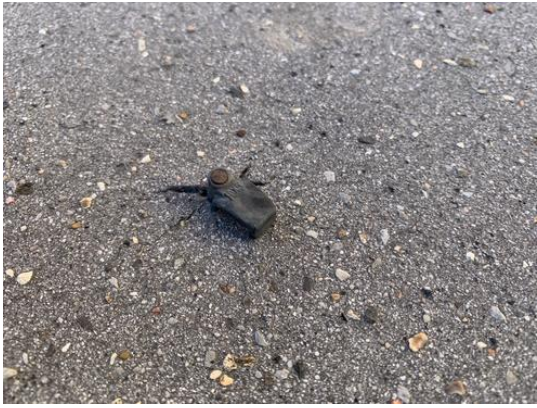
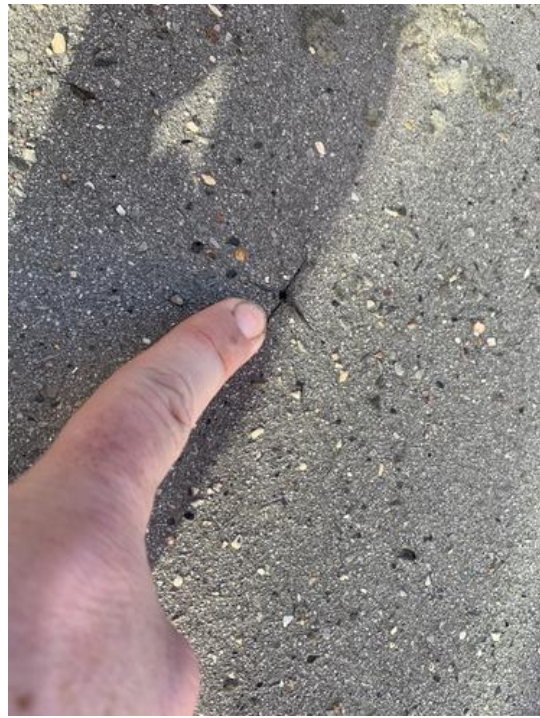
On the terrace roof there were some nails penetrating through the existing asphalt leaving areas open for water to get into the building.

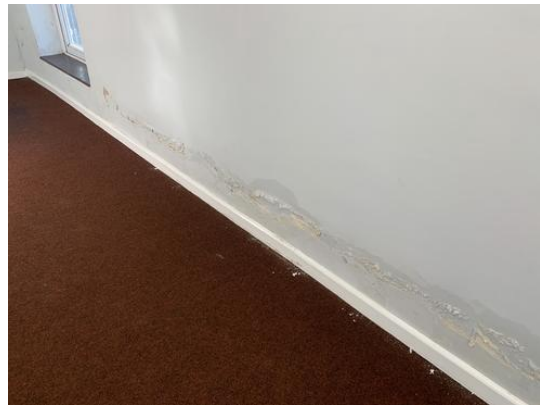
Photo 84

At the terrace level internally there were some signs of mould and damp on the walls, this is not caused by the roof terrace but by the issue with the damp brickwork which we would recommend is investigated further.
