**CONDITION REPORT
AND
CAPITAL EXPENDITURE MAINTENANCE PLAN**

**HUGHENDEN COURT
MOUNT PLEASANT ROAD
HASTINGS
TN34 3ST**

**Prepared for
Hughenden Court (Hastings) RTM Company Ltd**

JANUARY 2024

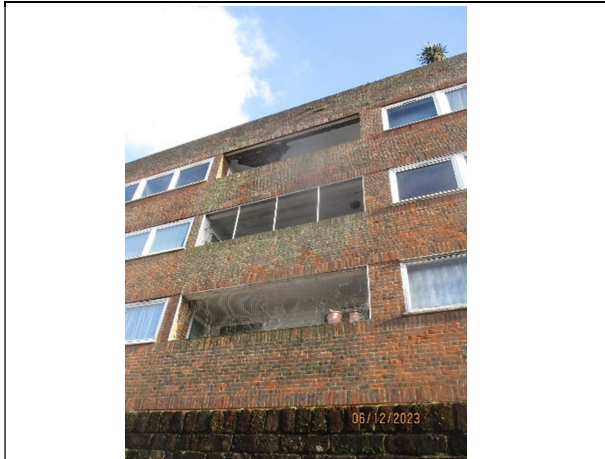
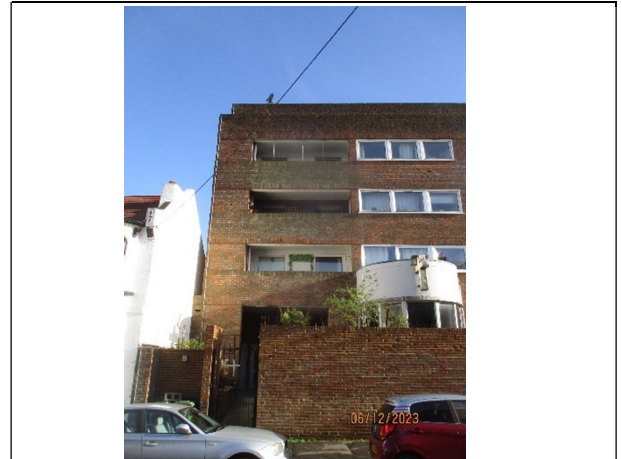
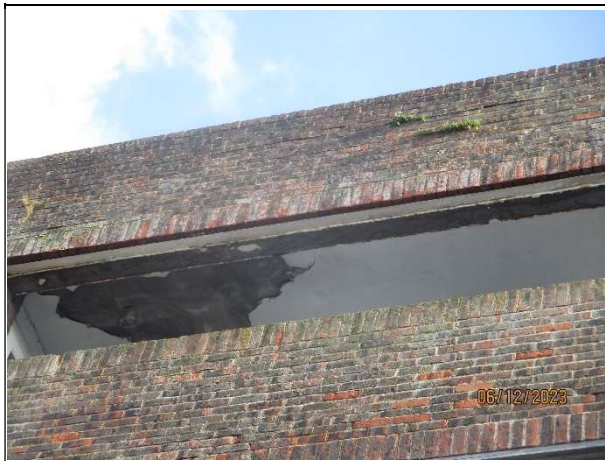
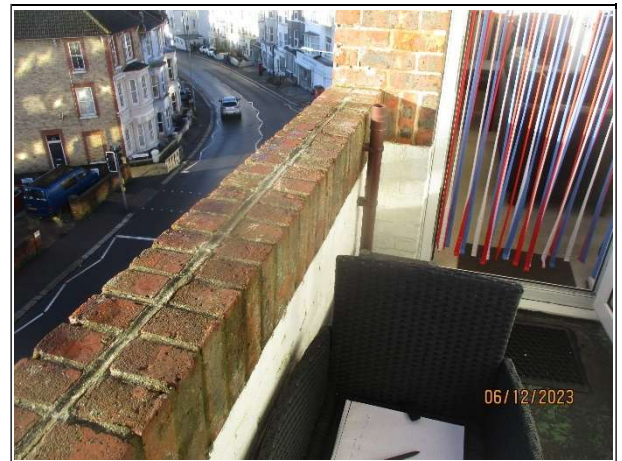
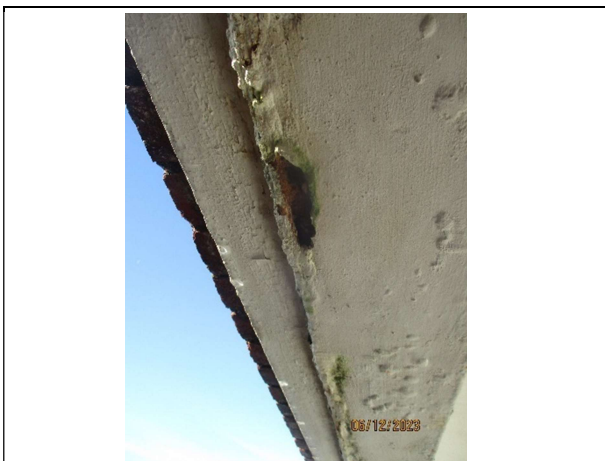
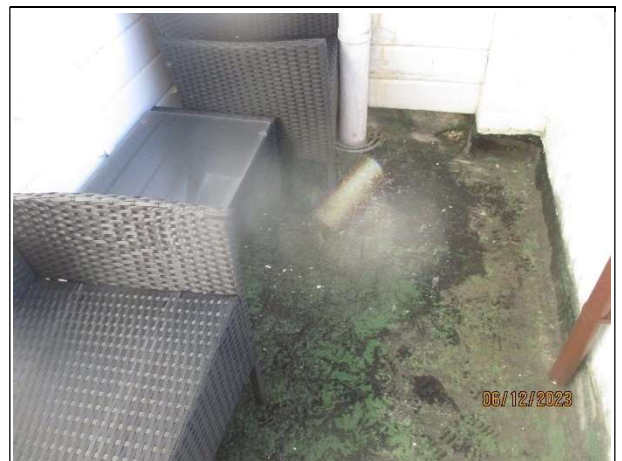
The cladding to the enclosed balconies will require redecoration as part of any future remedial works to the external elevations.

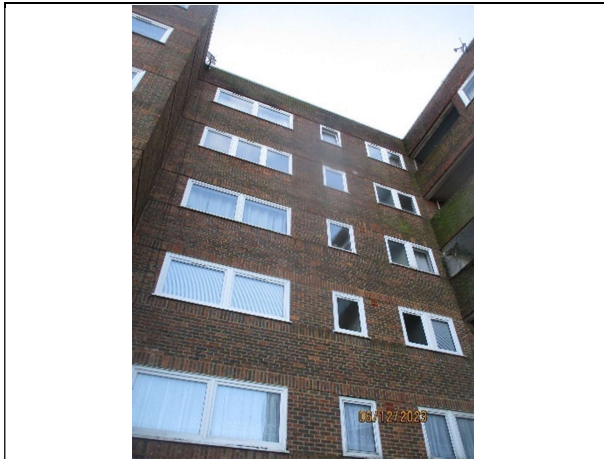
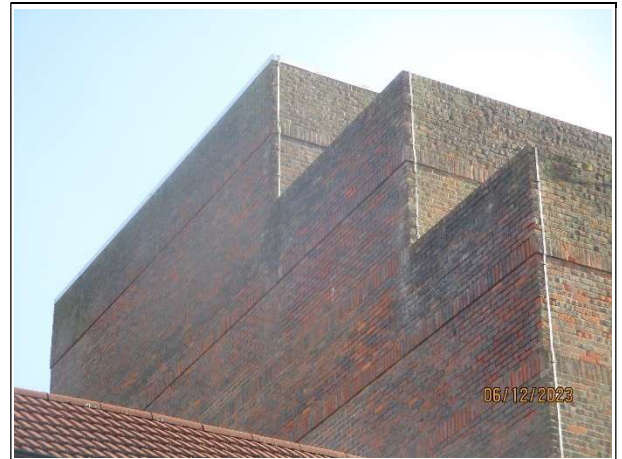
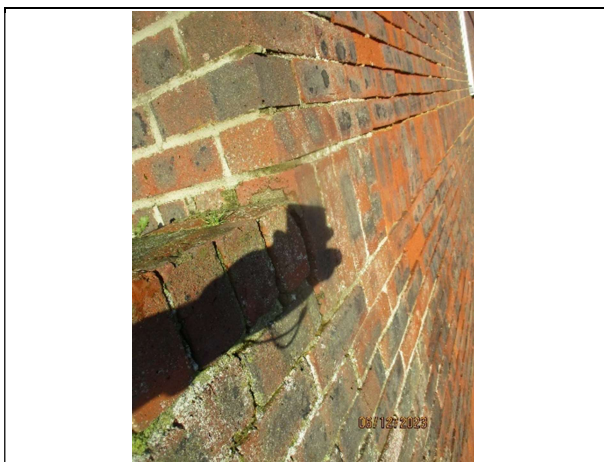
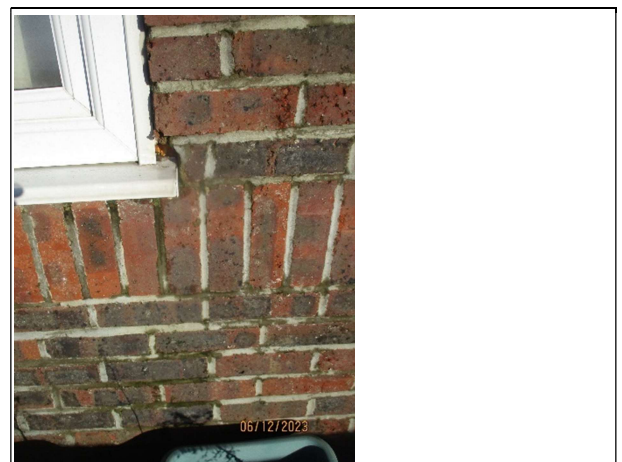
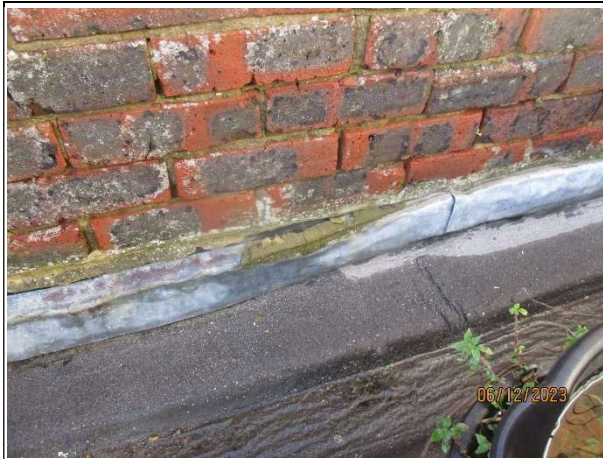
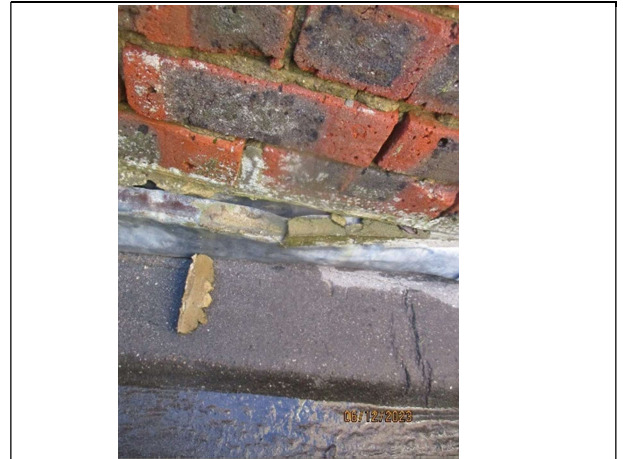
4.4 Elevations

The external elevations are formed of cavity construction with facing brickwork. Generally, the pointing to the brickwork is considered to be in poor condition with some significant areas where the pointing has eroded completely along with patches of brickwork that has suffered from substantial spalling.

As part of the recommended remedial works described above, it is also thought that due to the age of the building, that there are potentially issues with the cavity wall ties. An allowance will be included in the attached cost plan for replacement wall ties to all elevations. However, the full extent of this element of work will only be confirmed once close up investigations can be carried out from a scaffold. It is possible that the amount allowed within the cost plan may not need to be fully expended if it is found that some (or all) of the cavity wall ties are in an acceptable condition.

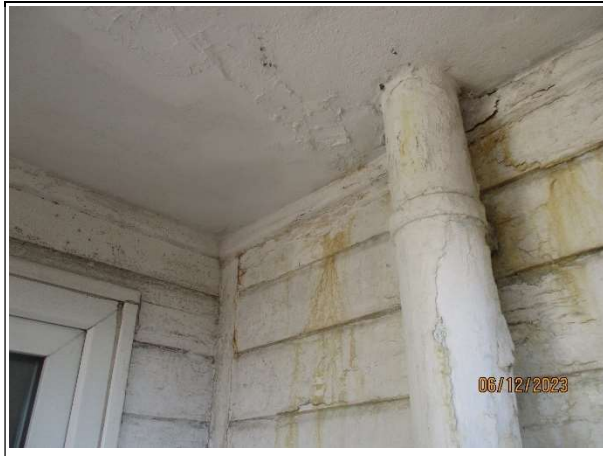
Some of the downpipes penetrate through the recessed balconies, and extend down to the undercroft parking area. We were only provided with limited access to a single balcony, but have been advised that there are ongoing issues with regard to water leaks that are likely linked to the boxed in rainwater downpipes.

Further investigation may be required to determine the location of any leaks, and a provisional allowance has been included in the cost plan for repair to be carried out.

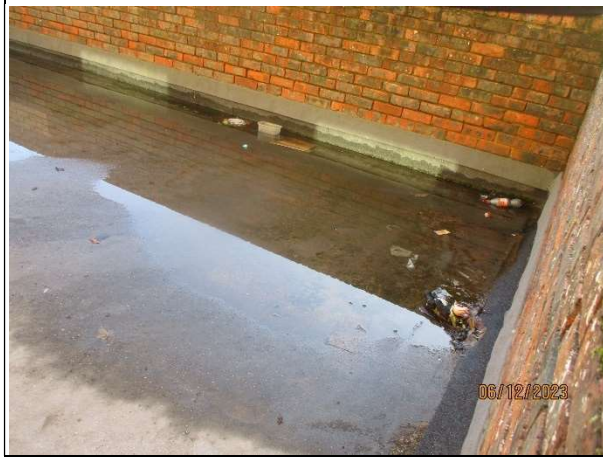
To the front and rear of the building there are terrace areas which are covered in asphalt with several brick built vents that serve the undecroft parking area at lower ground level. The asphalt surface is cracked in several areas and there is evidence of ponding in a number of locations. There is also evidence of water ingress to the car park area below. As a minimum localised remedial works will be required in the short term, but it is anticipated that longer term more significant repairs including replacement or recovering of the asphalt surface will be necessary. It is recommended that some core samples are taken of the asphalt in order to determine what condition it is in, and what the anticipated remaining lifespan is.

Water damage to the concrete ceiling within the car park area is an ongoing issue, and remedial works will be necessary. Further investigation is recommended to establish the extent and severity of any defects. A provisional sum has been included in the cost plan until a more definitive scope of works can be confirmed.

At the front entrance to the block, there are steps with a covering of concrete paving slabs. Remedial works including removal of weed growth, and replacement of the asphalt upstand will be required. There is also some damage to the metal handrail where it is fixed into the paving slabs that will need attention.

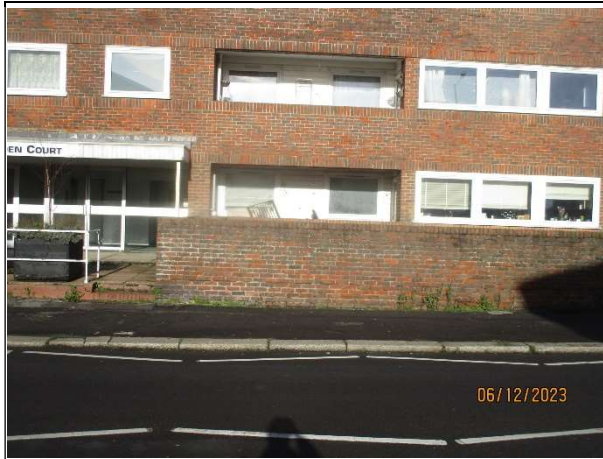
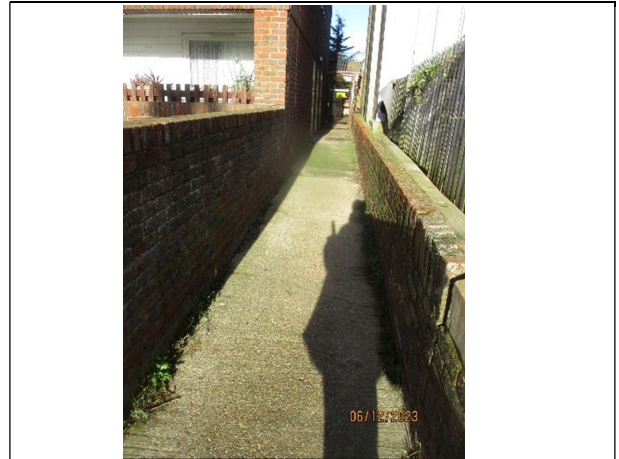
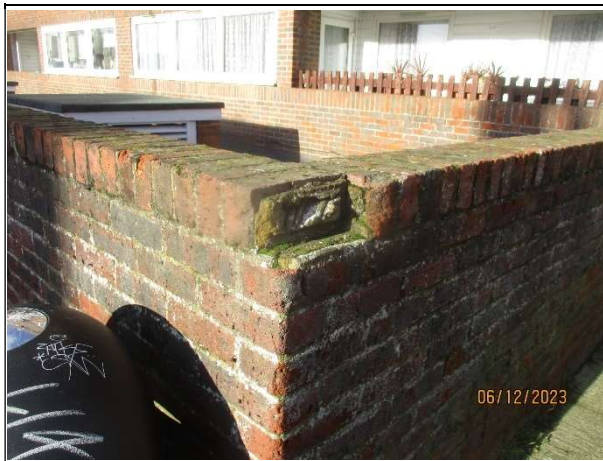
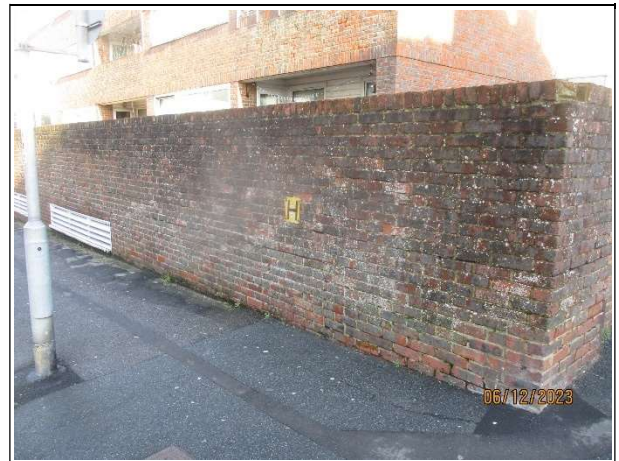
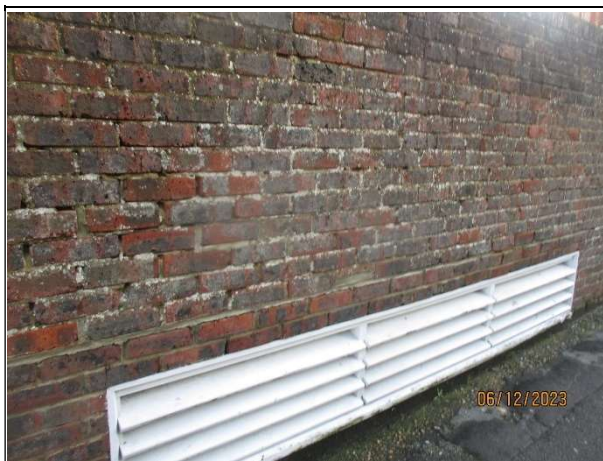
The front boundary is demarked by a brick wall which encloses the asphalt covered terrace area. This brick wall extends around the corner onto the west facing elevation. The brick wall becomes a retaining structure at the access road into the undercroft parking area. In general the boundary wall is in fair condition, but some localised repairs to frost damaged brickwork will be necessary.

There is an area of brickwork on the ramp to the car park area where a number of bricks have been removed and not replaced. These bricks should be replaced at an early opportunity.

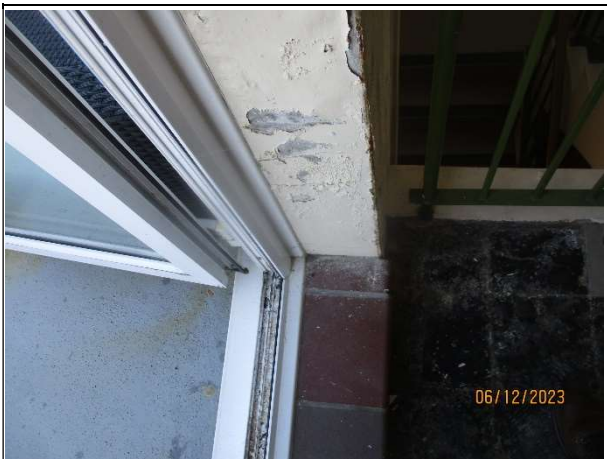
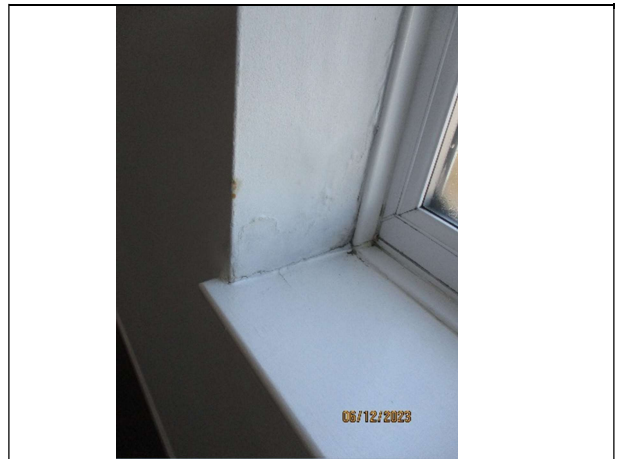
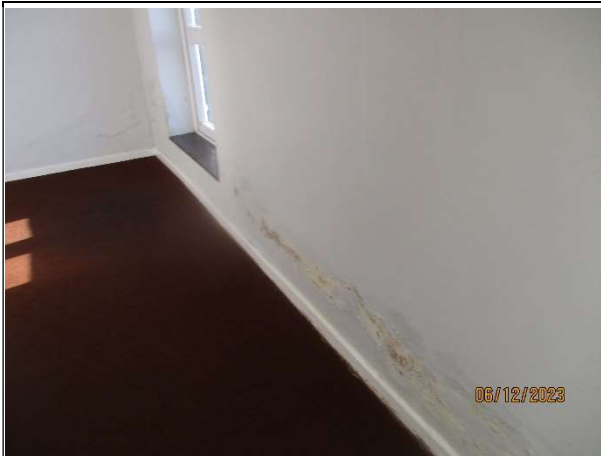
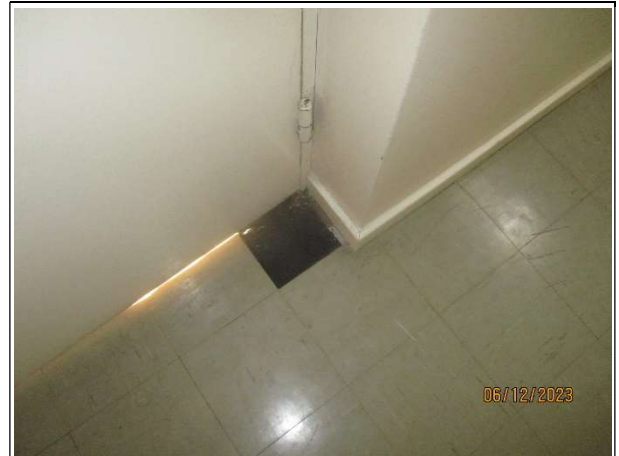
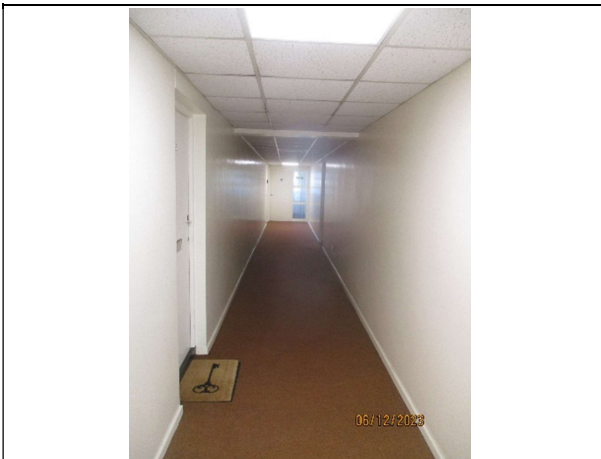
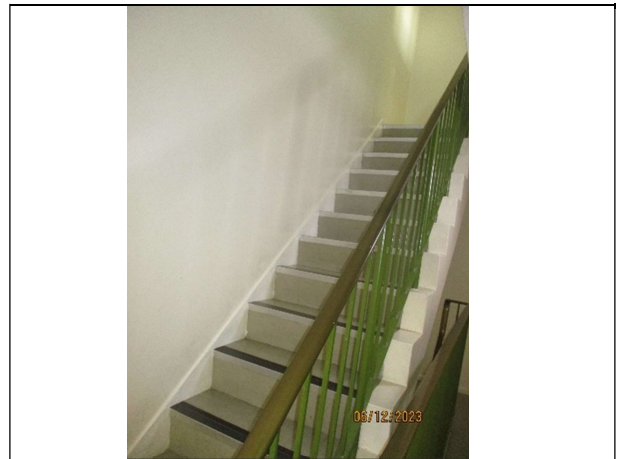
Painted decorations throughout the staircase and communal areas appear to be generally in fair condition, but with some areas having been damaged due to external water ingress. Due to significant and ongoing water ingress, some sections of walls to communal corridors will require remedial works before any redecoration should be carried out. As with the carpets, any external defects should be rectified prior to carrying out any internal making good and redecoration. An allowance for redecoration of the communal areas has been included in year 5 of the maintenance plan.

The ceilings to the communal areas are generally suspended ceiling tiles. For the most part the ceiling tiles are in fair condition, but some water damage has been caused in a number of locations. Similar to the carpets and walls detailed above, any ongoing defects should be rectified prior to any repair works.
