Survey Report

Hughenden Court, Mount Pleasant Road,
Hastings

Project Name	Hughenden Court, Mount Pleasant Road, Hastings
Area Name / Reference (if applicable)	No 35 terrace
Client	Homeowner/Director
Report Conducted By	Bob Saul
Site Visit / Report Date	2023-01-06

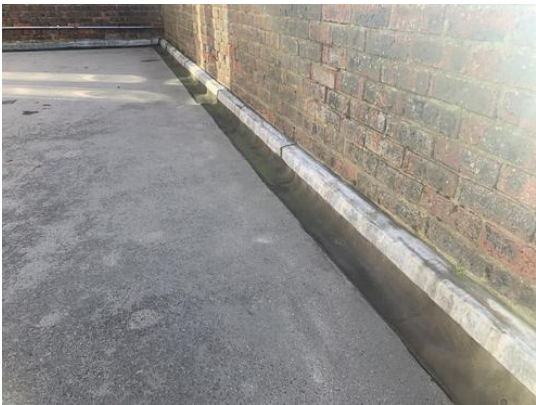
Photo 49

There are various cracks in the existing asphalt roof covering which will allow water into the building.

Any areas where the existing waterproofing is damaged, cracked can be repaired then it should be repaired, primed with BITUMEN PRIMER+ SA and a SELFDAN AP 2000 AVCL installed to any areas this occurs
